# Improvements on the ALBA synchrotron light source operation reliability

*Ferran Fernandez*

*ARW2015*

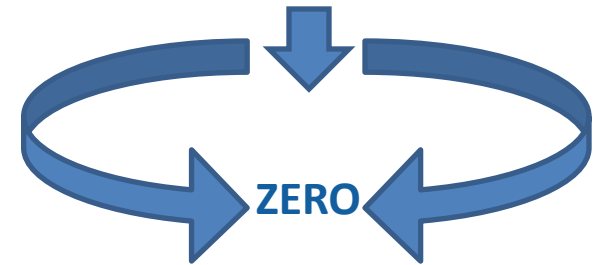
- *180° circulation with zero velocity point*

- *Actions to improve (I): 180° to 360° & invert during shutdowns*

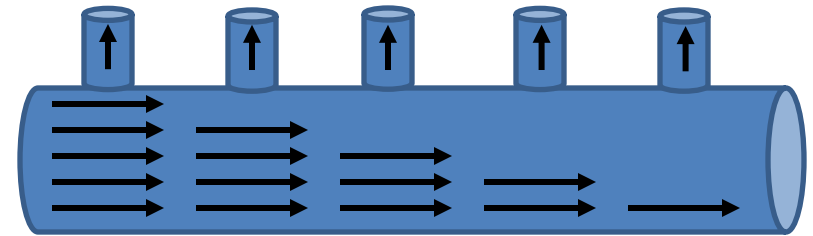
- *Due to the constant diameter of the pipe along the distribution ring, the velocity decreases*

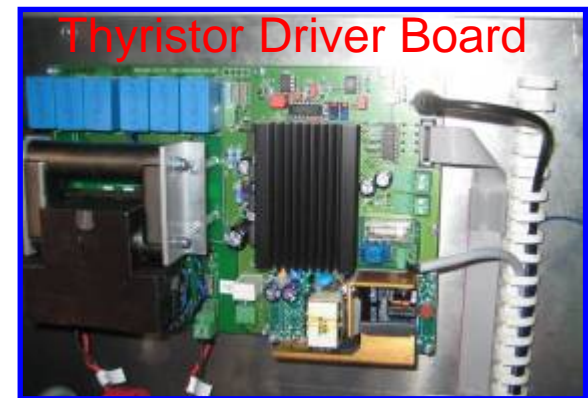
- The thyristor driver board of kicker 02 of the storage ring had an erratic behavior: 1 trip/malfunctioning per month

- Damaged components: MOSFET IXDN614 and IXDI614, which are the gate drivers used to switch the thyristors
- A TLD radiation study showed high dose levels focused at kicker 2.

KICKER 2	KICKER 3
GAMMA DOSE PER MONTH (Gy)	3300	8

- Polyethylene and lead shielding was installed. After shielding, failures disappeared
