Reliability concerns with the SNS Machine protection Sytem

Doug Curry,
Eric Breeding,
Alan Justice

ARW May 1, 2015

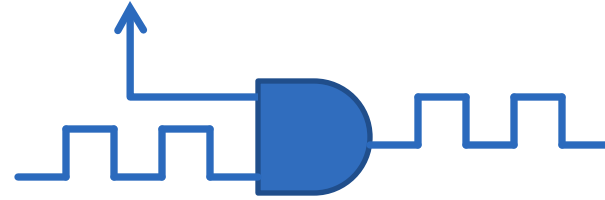
- Output enable stuck high

- Provides a false MPS status to the top level node and permits continued beam production

- Firmware implementation did not match the architecture approved by the review committee

- Single clock source generated at the lowest node in the chain
 - Each node simply grants or prevents the passing of the permissive signal
- Passed local clock reference instead of original clock source

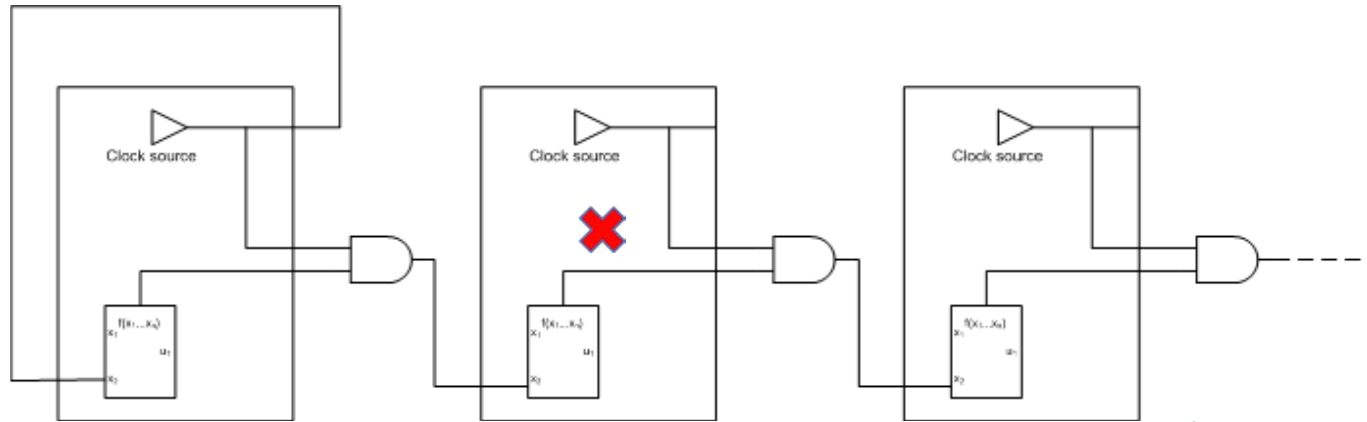
Reporting false positive MPS status

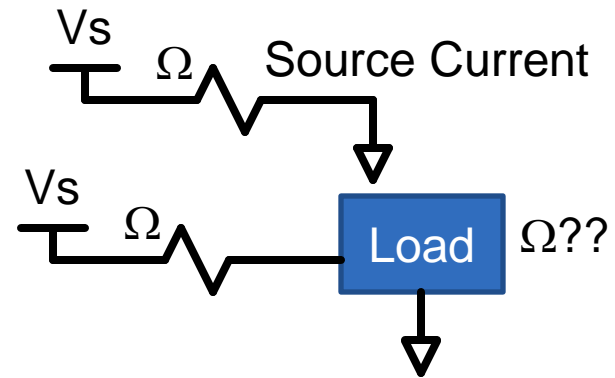
- Low current drivers
 - Increased complexity
 - Non-standard configuration
- High density connectors
 - Bent pins “stuck high” status shorted to power pin
- PLC interfaces
 - Single digital output interface “solid state output”
- Operating System errors
 - Software interlocks
- Hardware Assembly inconsistencies
