ISIS Main Ring Dipole Coil Failures

30th April 2015

Accelerator Reliability Workshop
Knoxville

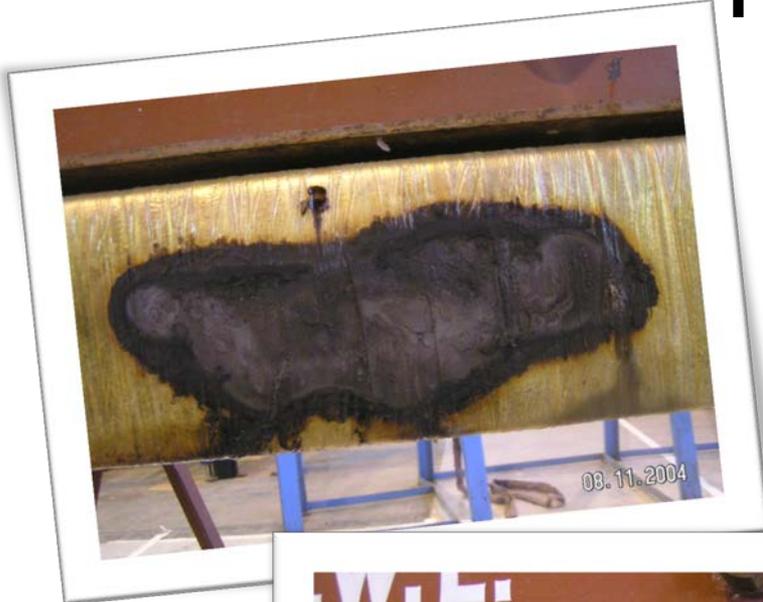
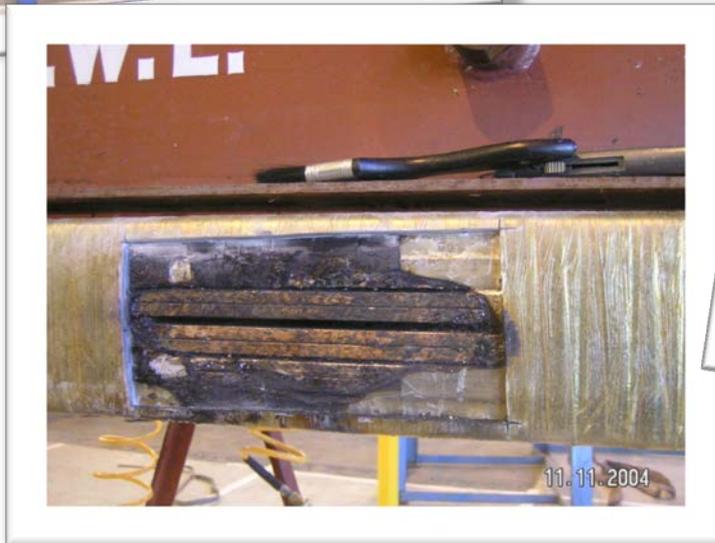
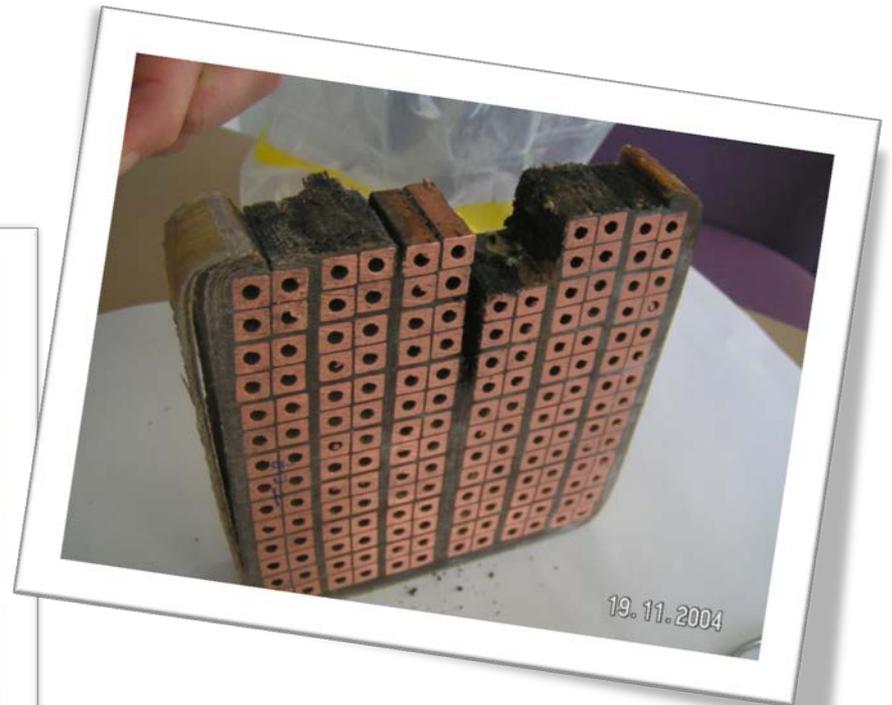
- Original coils made by Tesla Engineering in early 1980's
- Constructed using a Mica / Glass tape then vacuum impregnated
- Original coils in service since then (some are still going...)
- Started to see failures in 2002

- Further failures in March 2003 and October 2004
- We have a problem!

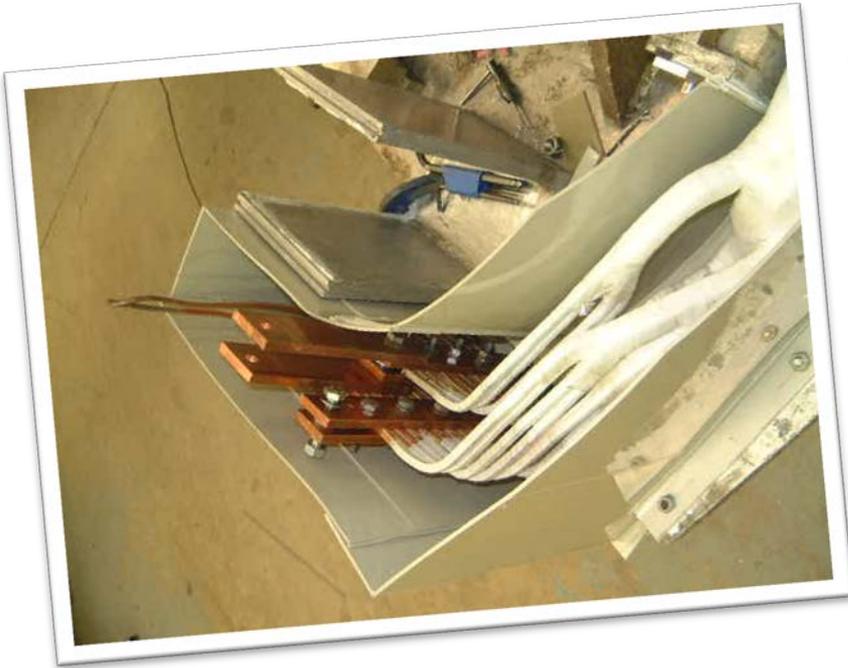
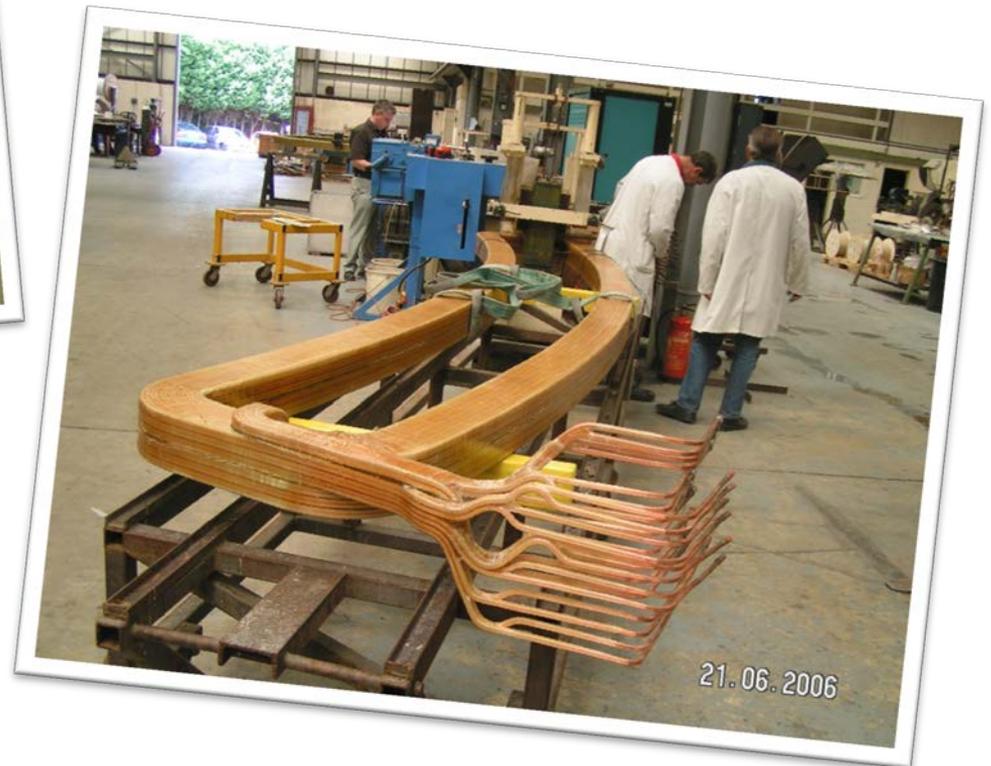
- Many failures on original magnets are in the same area
- Insulation on new coils is strengthened in this area

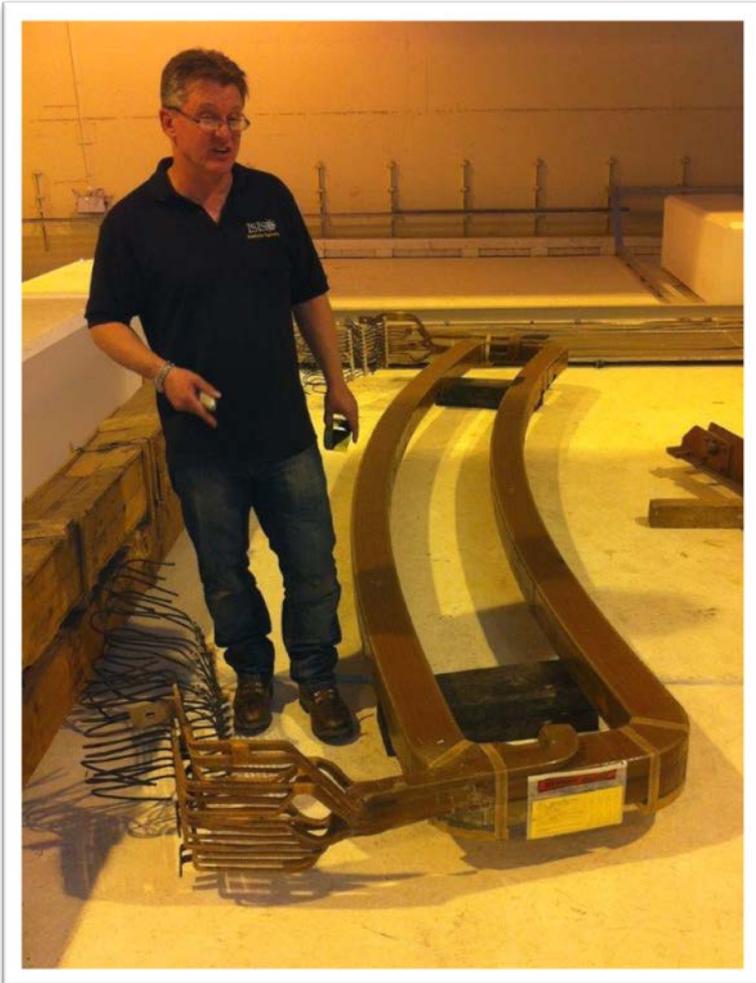
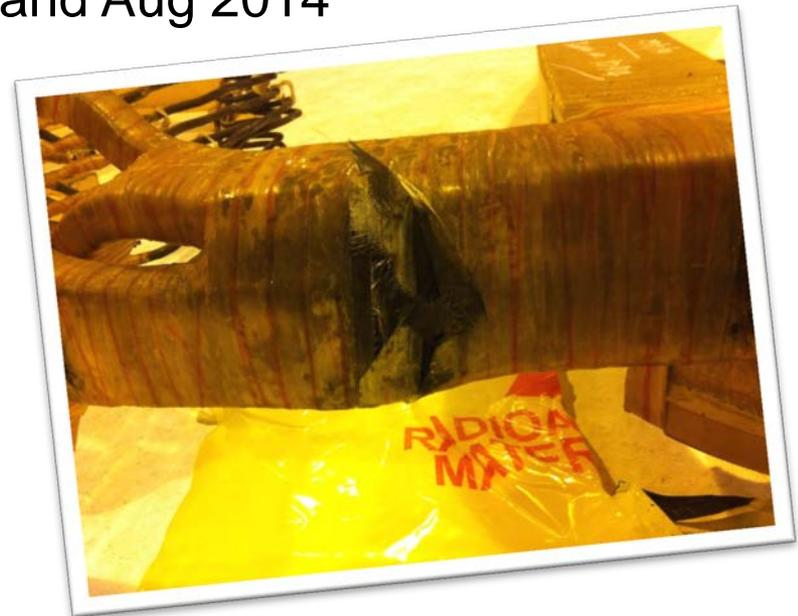
- Failures continue in May 2011, May 2012 and Sept 2012
- More fail in 2013
- First new coil fails in Nov 2013
- Now believe we have a serious problem
- Further failures of new coils in Feb, May and Aug 2014

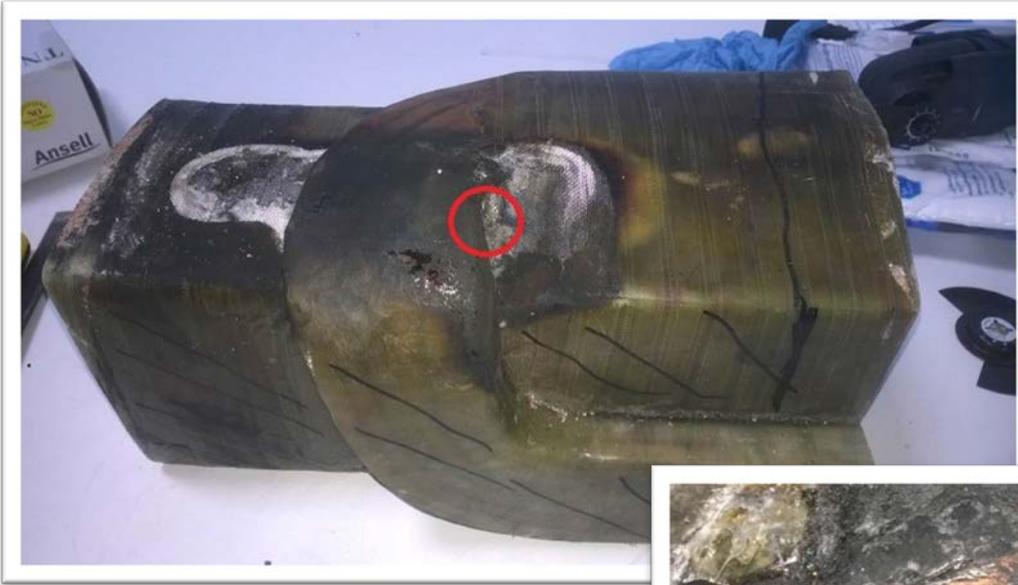
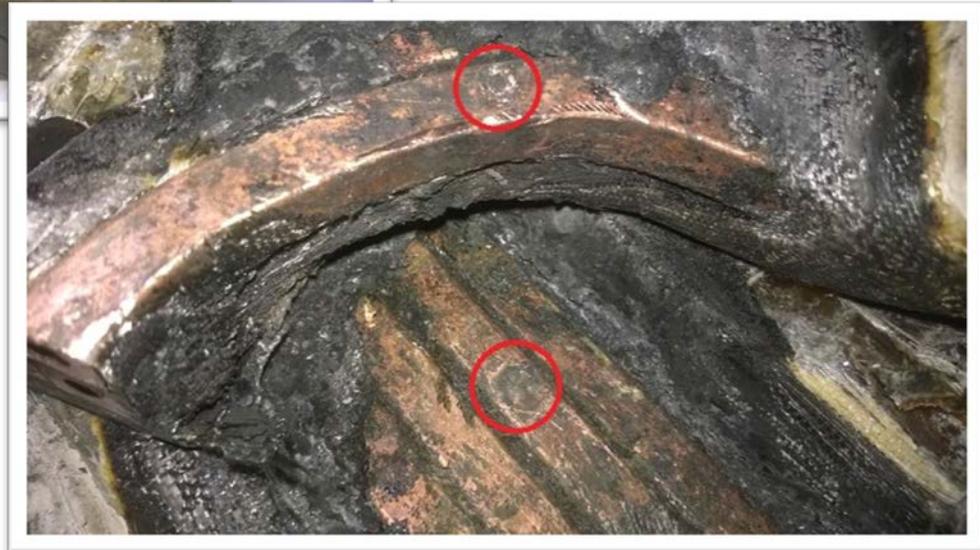
- Pull failed coils apart –
What can we learn?
- Failures often sub-coil to
sub-coil

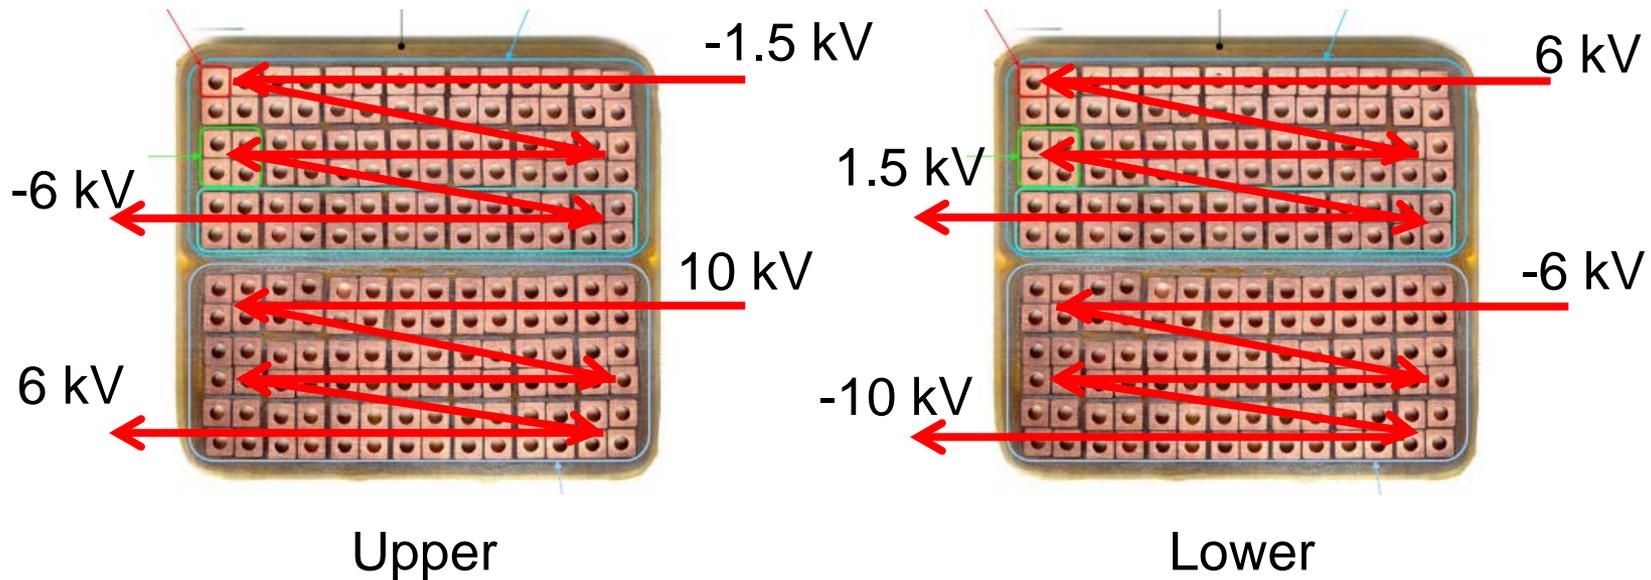
- More upper coils had failed than lower
- Look at the design in detail ... there could be a good reason!
- Pancake termination sequence different
