# MEBT Water to Vacuum Leak

Geoffrey Milanovich  
SNS Operations

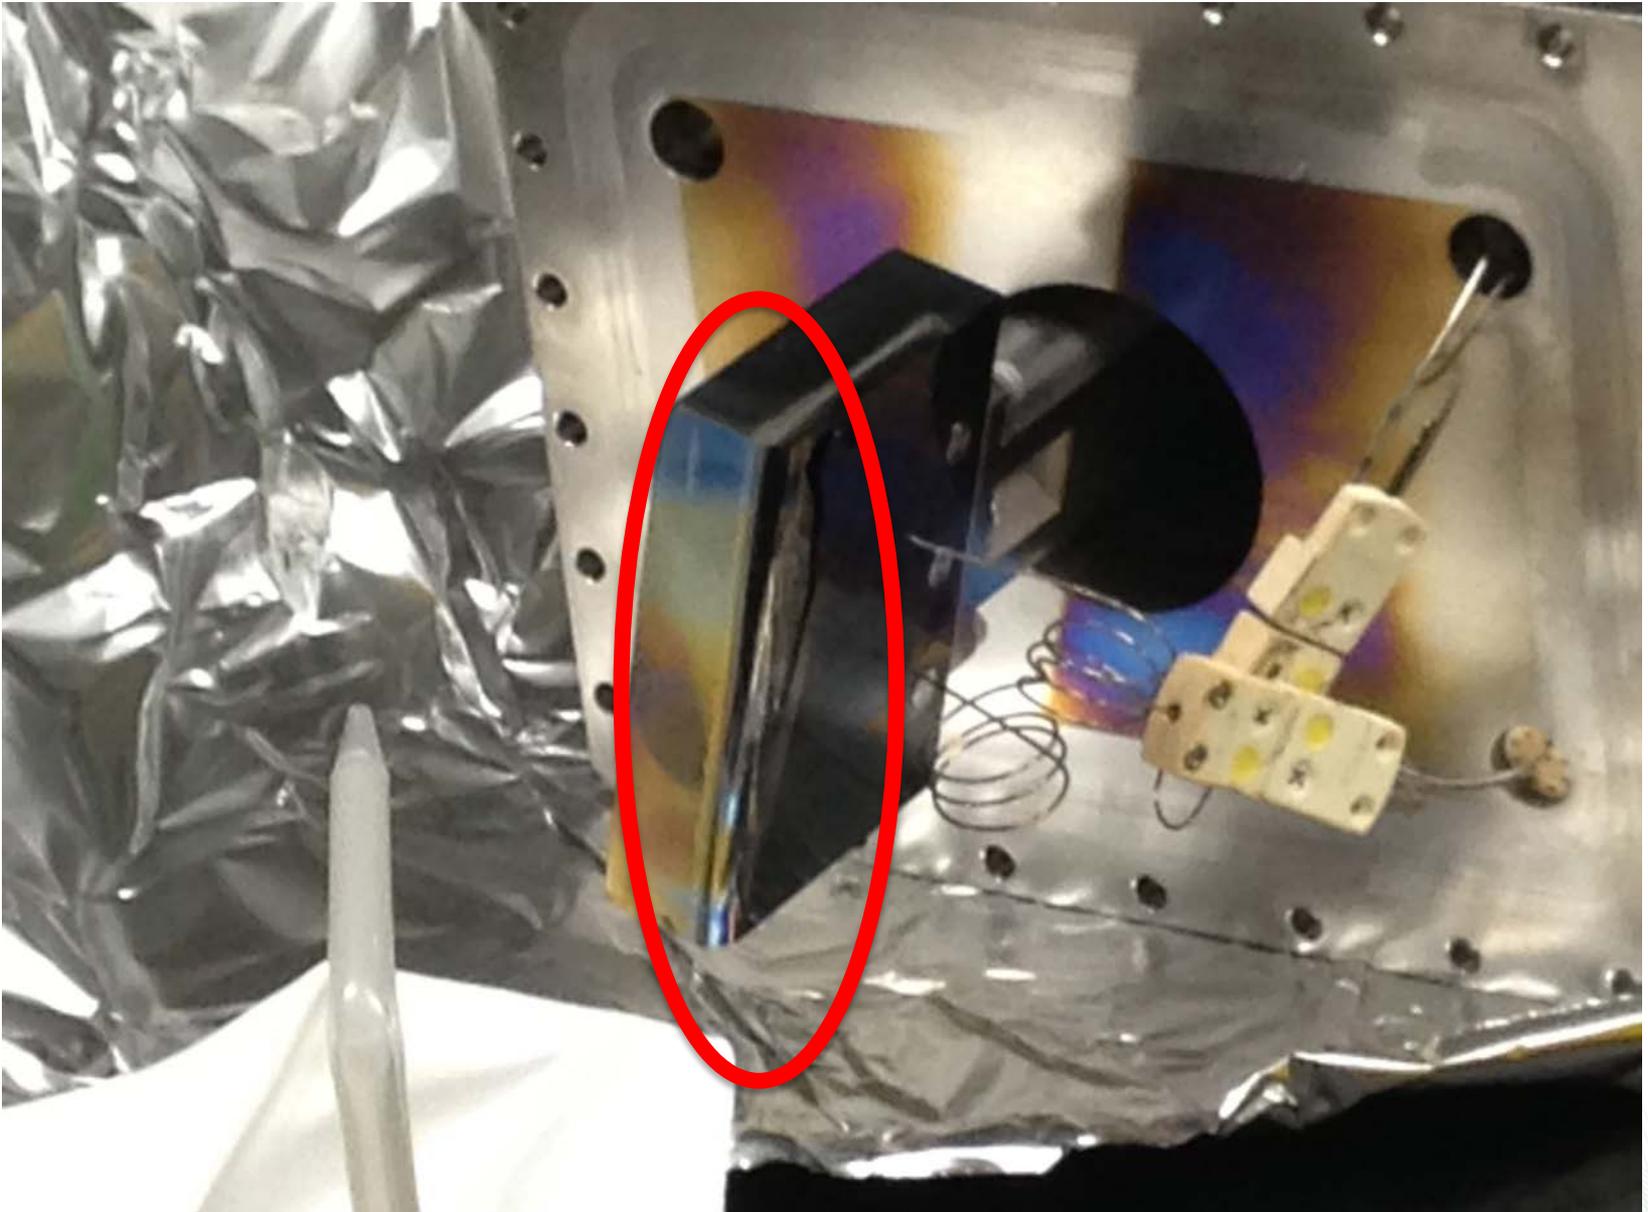
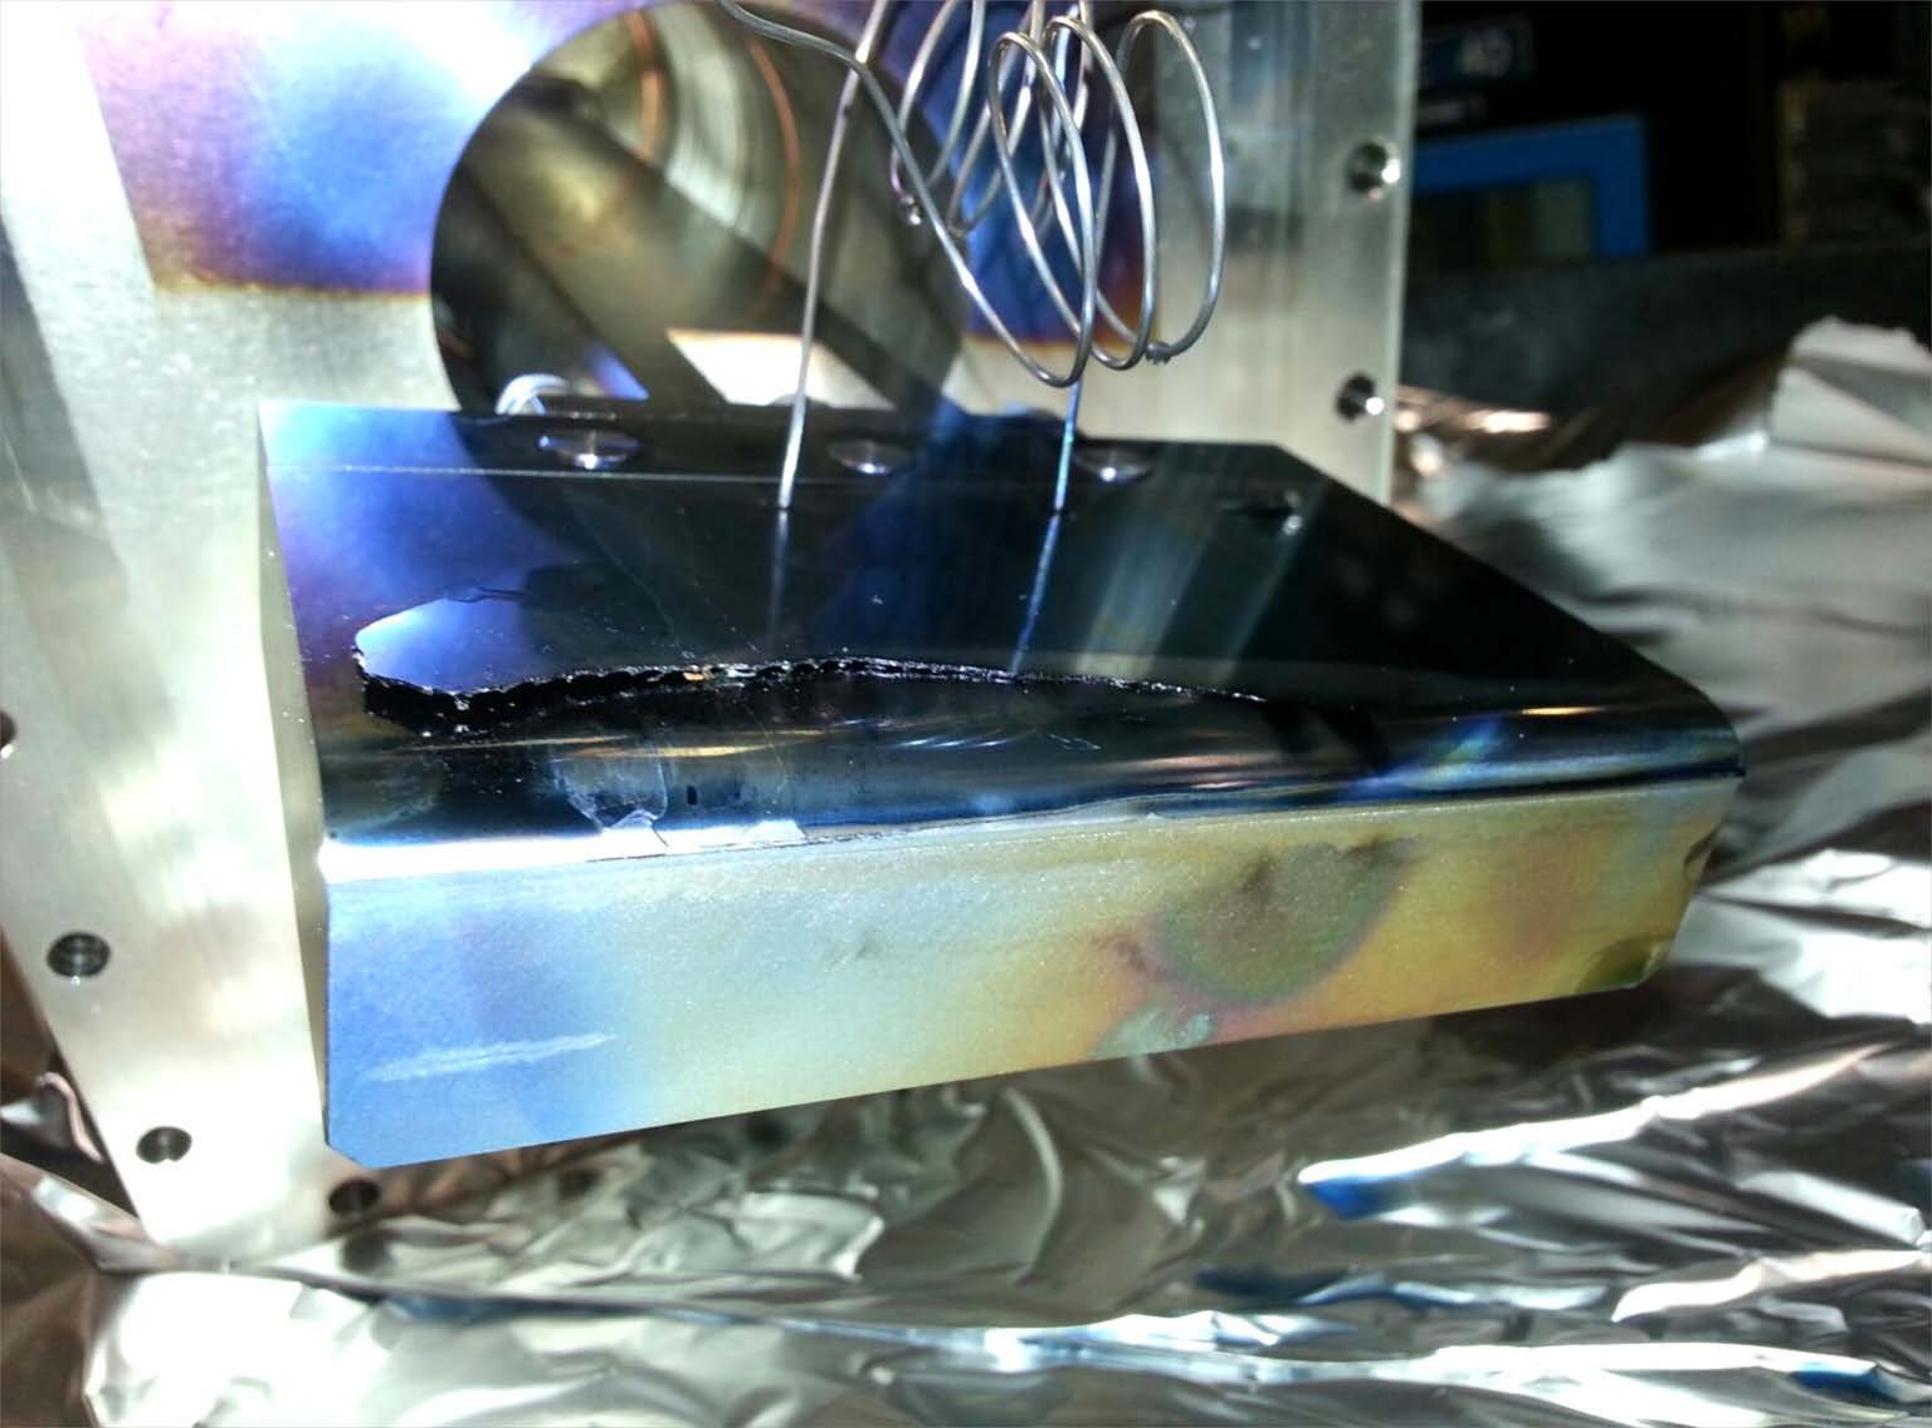
# Chopper Target Failure

- Front plate: TZM (molybdenum alloyed with titanium and zirconium)
- with 0.5 mm water-cooling micro channels
- 1 mm thickness between the water channels and the front plate
- Design max power **500 W**
- Beam power in MEBT at 1 MW on target is 2500 W
- Usually scraping 1-2%, < **50 W**
- May be the heating-cooling cycles affected the front plate + “hydraulic hammer”

- Low power tests of rebunchers to verify operation.
- Conditioned RF (with extra shielding) before reassembling beam line.
- Reassembly is simply the reverse of disassembly.
- Everything reinstalled except chopper target.

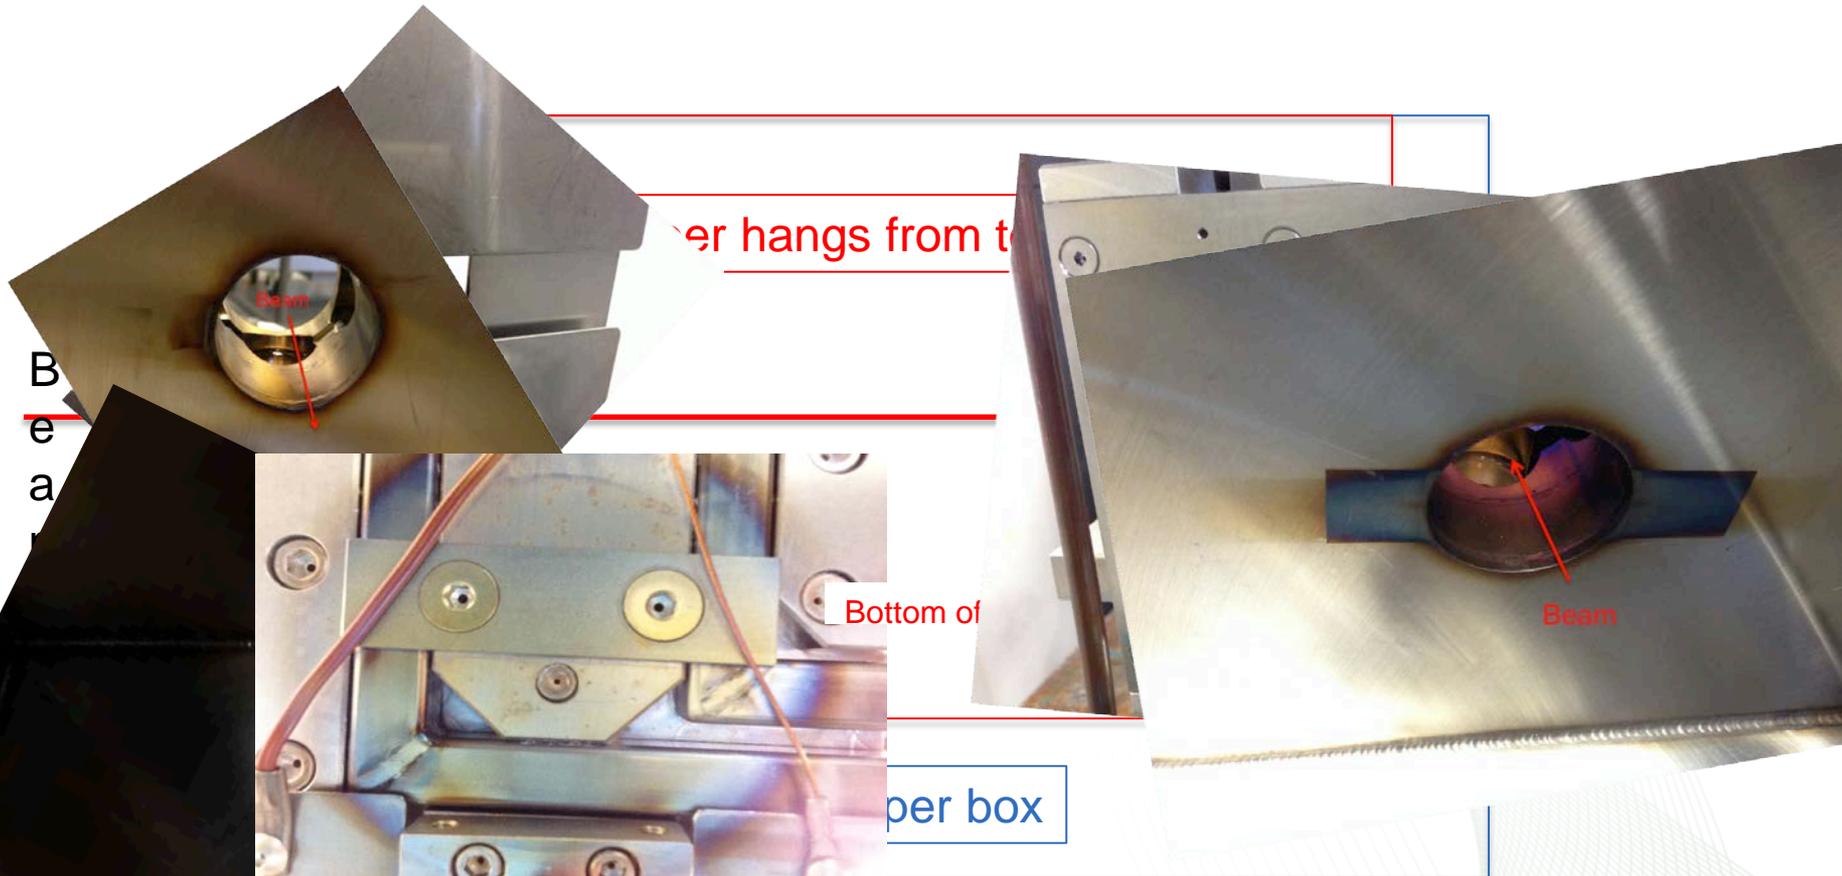
- Chopper box (before target) showed unusual heating

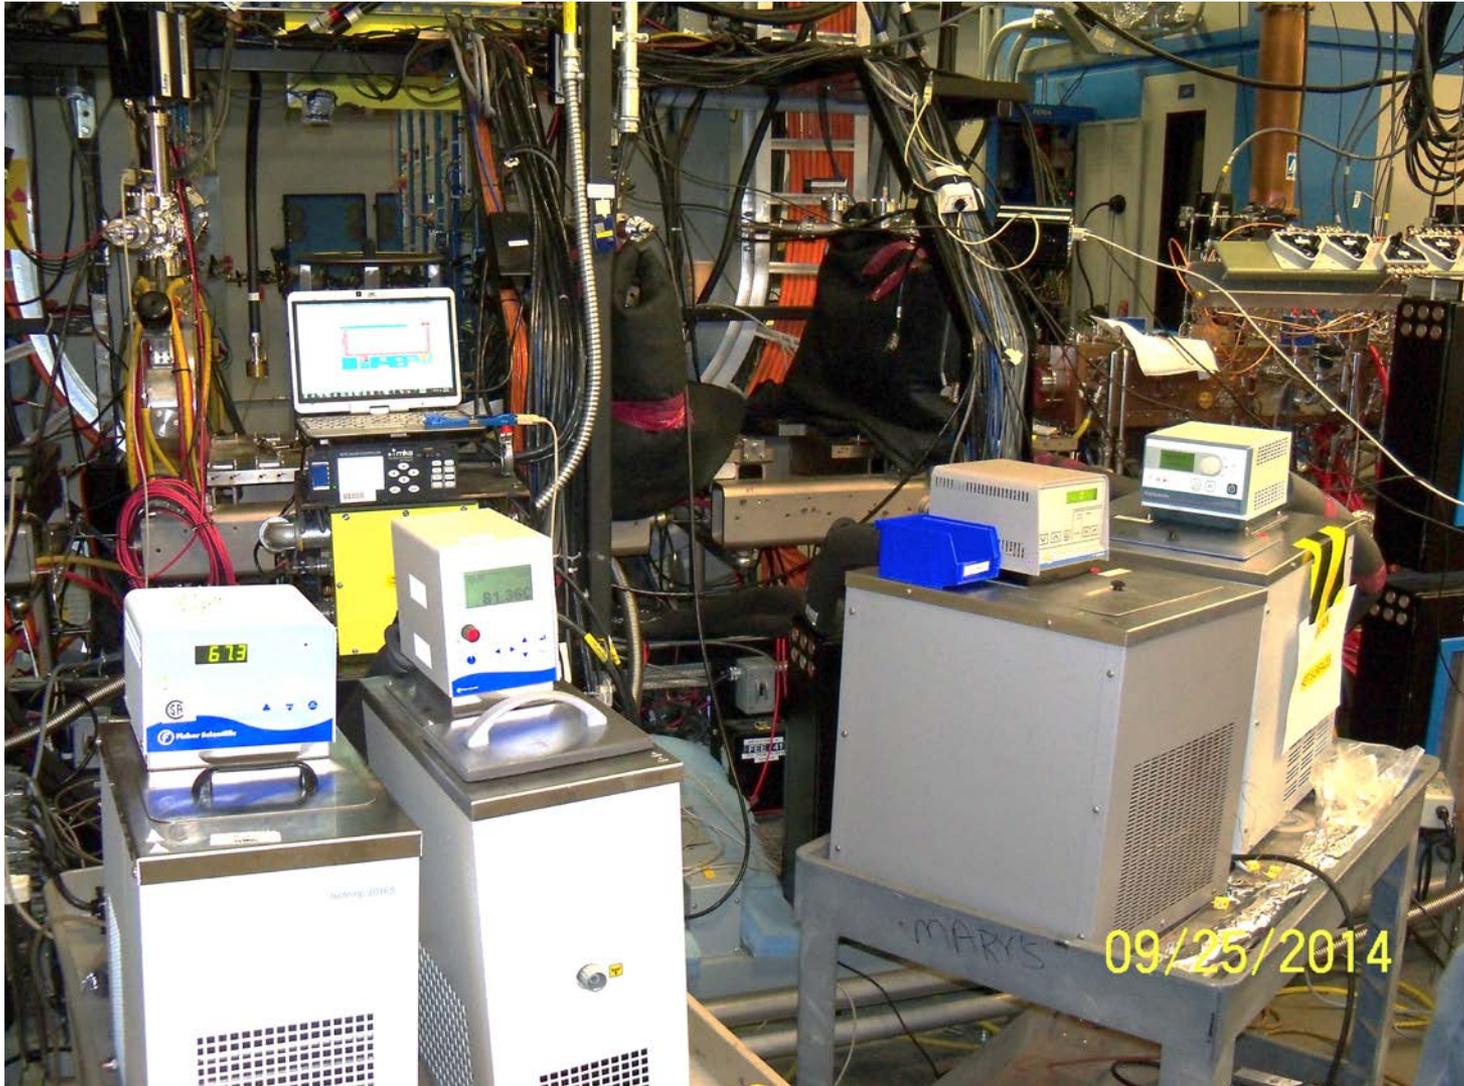
# Dewatering Rebunchers

- Wanted to keep on beamline, some critical seals unavailable, long lead time to manufacture
- Decided to raise temp and keep under vacuum to pump out water, but not too hot to protect seals
- Tried heat lamps and heated nitrogen gas, but ineffective
- Heated water through cooling channels effective to raise cavity temperature ~ 95 C

- Our Vacuum Engineer computed that it would take ~ 4 days to pump 1 cc of water, and estimated ~ 5 cc could be trapped in the cavity
- **TOO SLOW!**

- Change to a glycol mix and raise temp  $> 100$  C
- Rebunchers 2-4 processed to good vacuum in 5 days.
- Rebuncher 1 took 8 days
