Operation Reliability of J-PARC Main Ring

Masashi Shirakata

KEK/J-PARC

ARW2015 (27th April to 1st May)

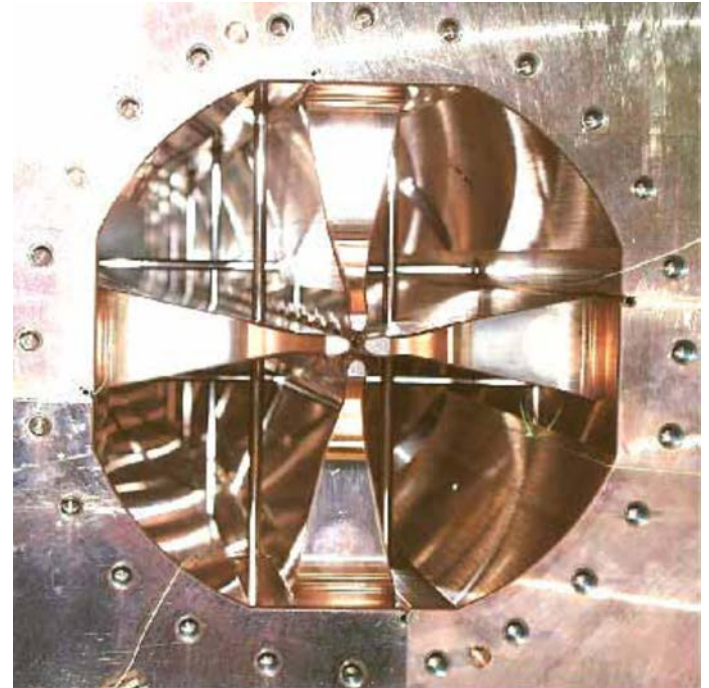
Inside view of RFQ

RFQ (Radio Frequency Quadrupole) uses electric quadrupole field for beam focusing. Discharge may occur at the surface with high voltage potential.

Discharge problem in the RFQ

- ⑩ The first severe discharge problem in the RFQ occurred in September 2008.
- ⑩ Before this problem, the availability of linac was more than 90 %.
- ⑩ After the problem, we are suffering from sporadic unscheduled shutdown due to discharge problem in RFQ.
- ⑩ A run cycle scheduled in Oct. 2008 was cancelled for RFQ conditioning.
- ⑩ The RFQ downtime (both scheduled and unscheduled) dominated the machine time in runs in Dec. 2008 and Jan. 2009.

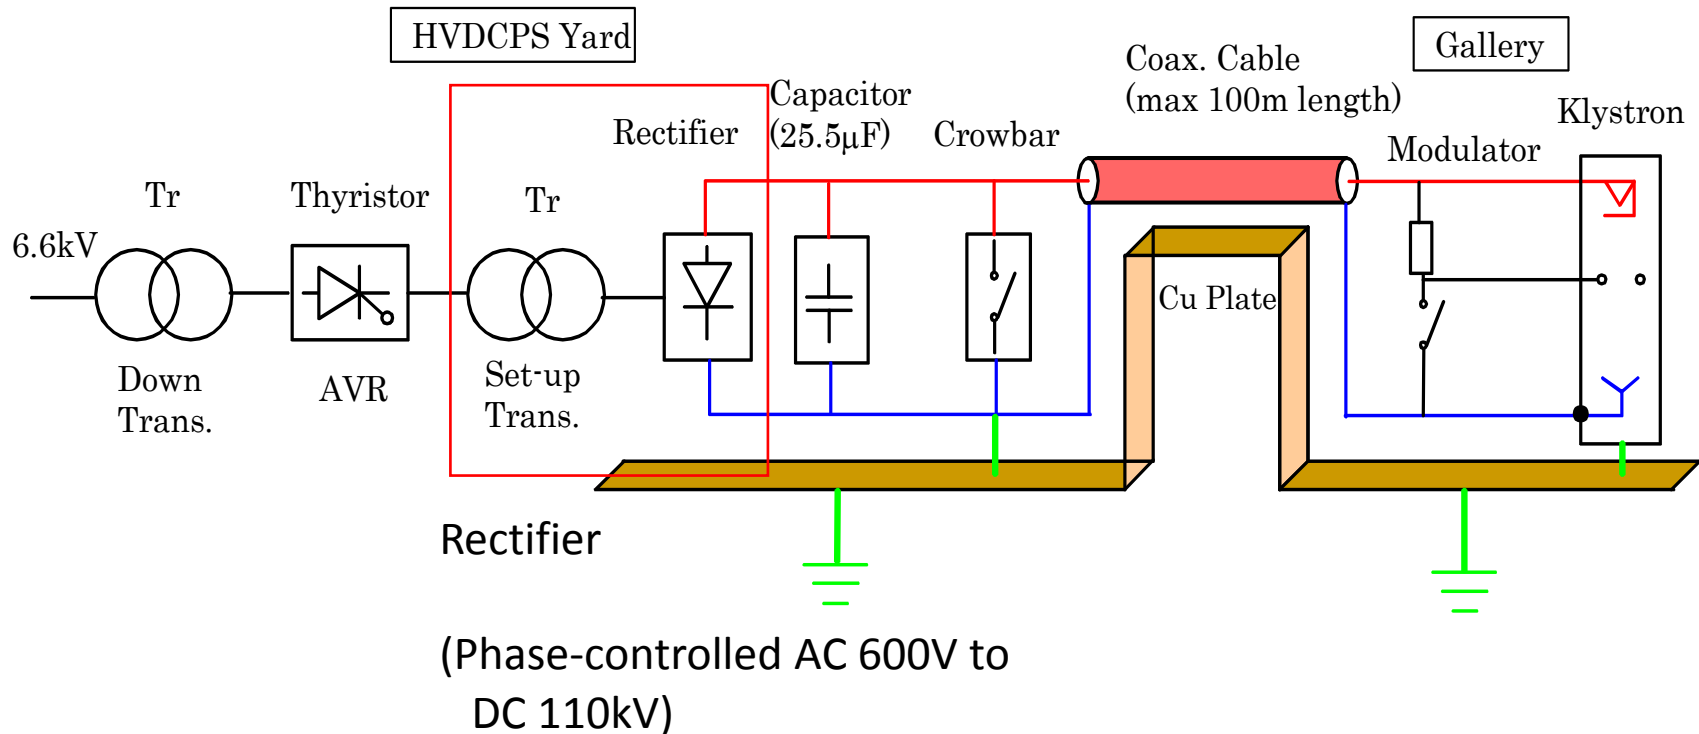
Klystron DC power supply No.1 (HVDC01)

HVDC1: power source of RFQ, DTL1, DTL2, and DTL3

Step-up Rectifier

Breakdown of diode

Recovery

Exchange HVDC01 <-> HVDC11 (4 days)

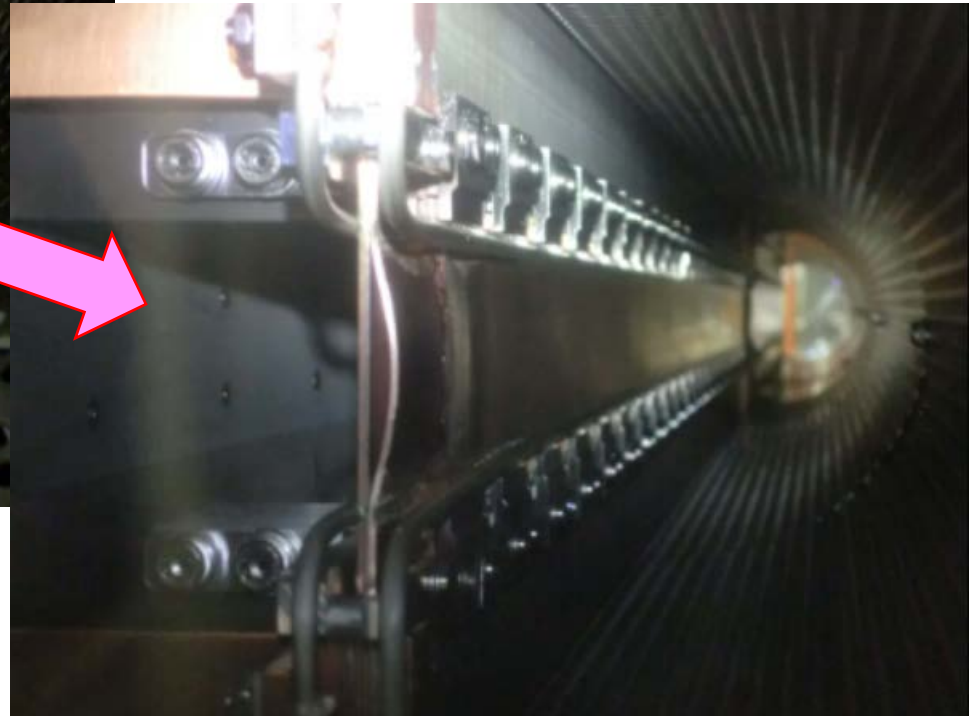
14th Mar. 2013

Conductor at the downstream **bended out** to the circulating beam!

SX_SMS1 break down (37 h), HD beam was cancelled.

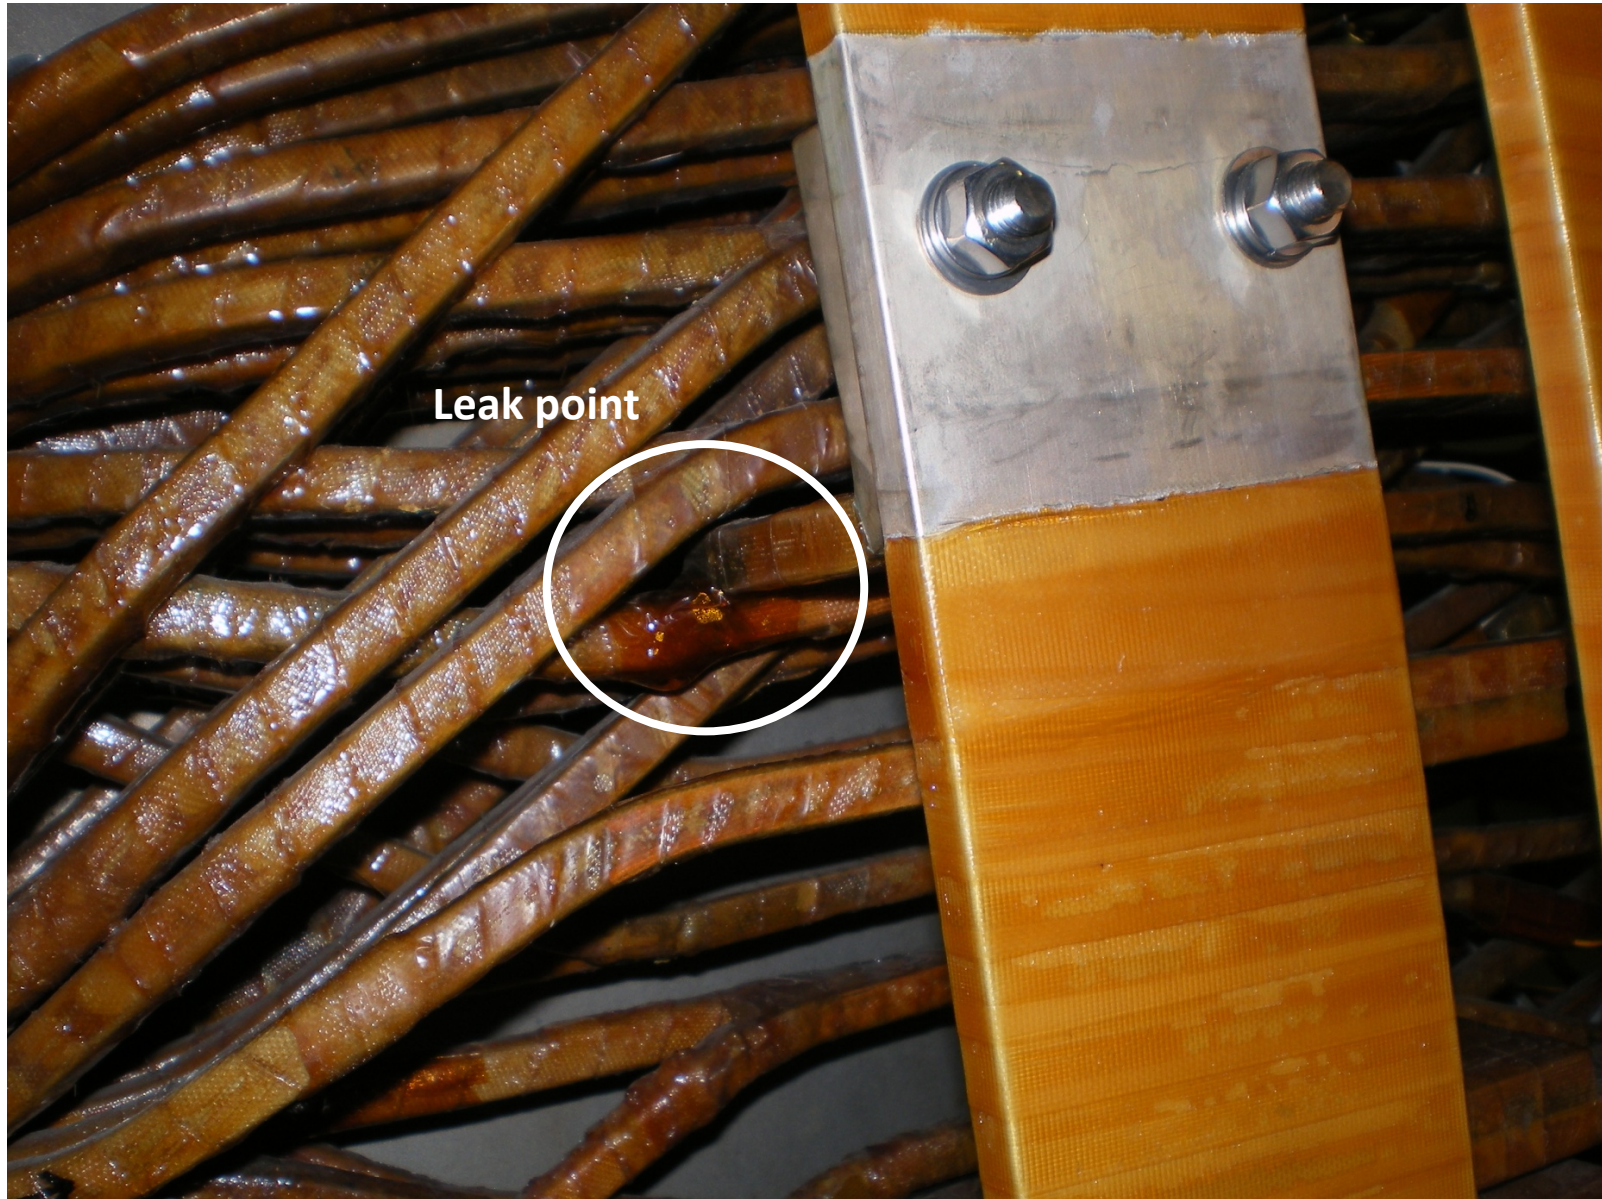
Injection septum 1

Leak point

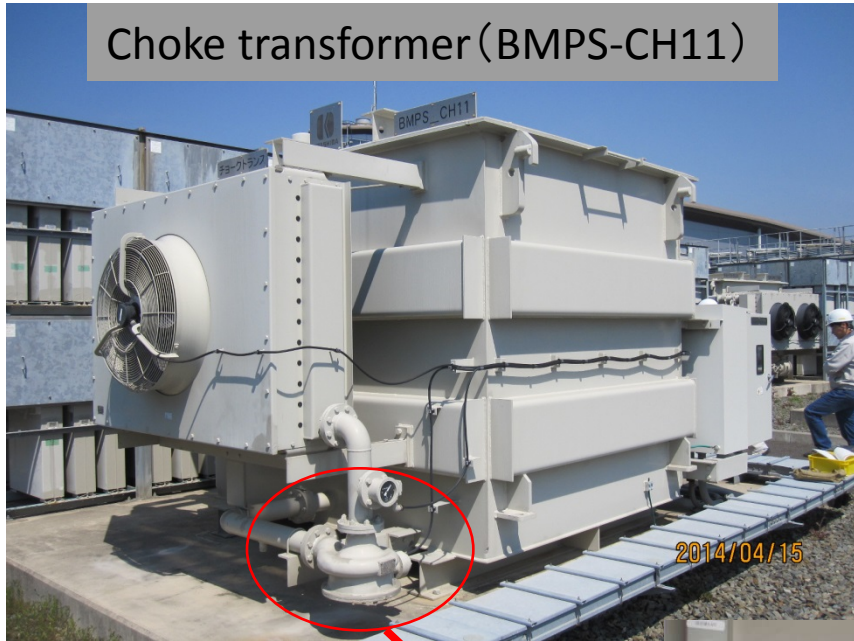
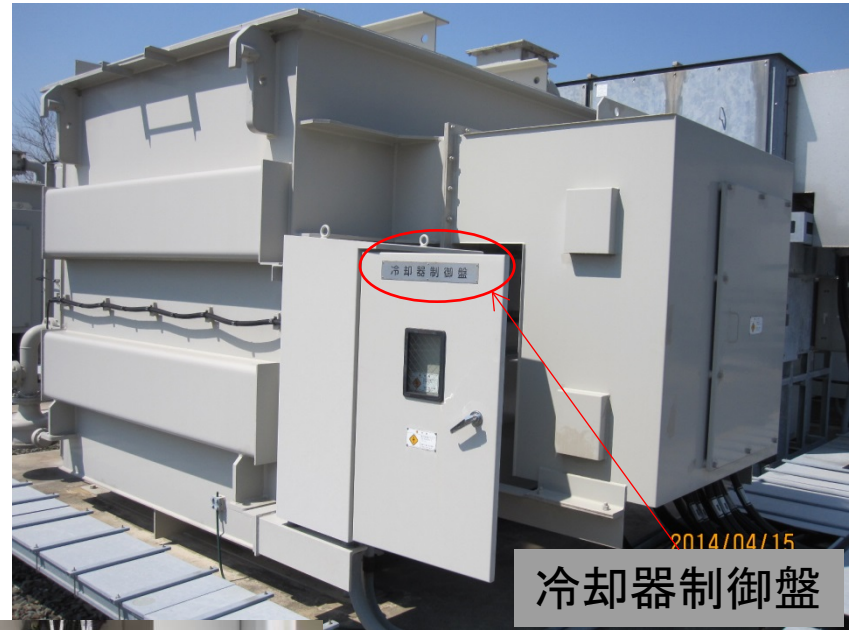
Choke transformer (BMPS-CH11)

- 15th 08:52 Breakdown of a thermal relay for the oil pump of BMPS_CH11
The cause was found out to be a breakdown of the oil pump.
- 16th, 17th Preparation and scheduling
- 18th Replace the pump
- 19th Current test, and startup magnets (It takes time to heat-up the magnets)
- 20th Beam tuning
- 21st 09:13 Recovery the user beam

Spare parts are ready now. It takes 3 days for recovery at the next time.
