Availability Challenges and Solutions Associated with the High Voltage Converter Modulator at the Spallation Neutron Source

Presented at the
**Accelerator Reliability
Workshop**

**David E. Anderson, HV, PP & MS
Manager, Research Accelerator
Division**

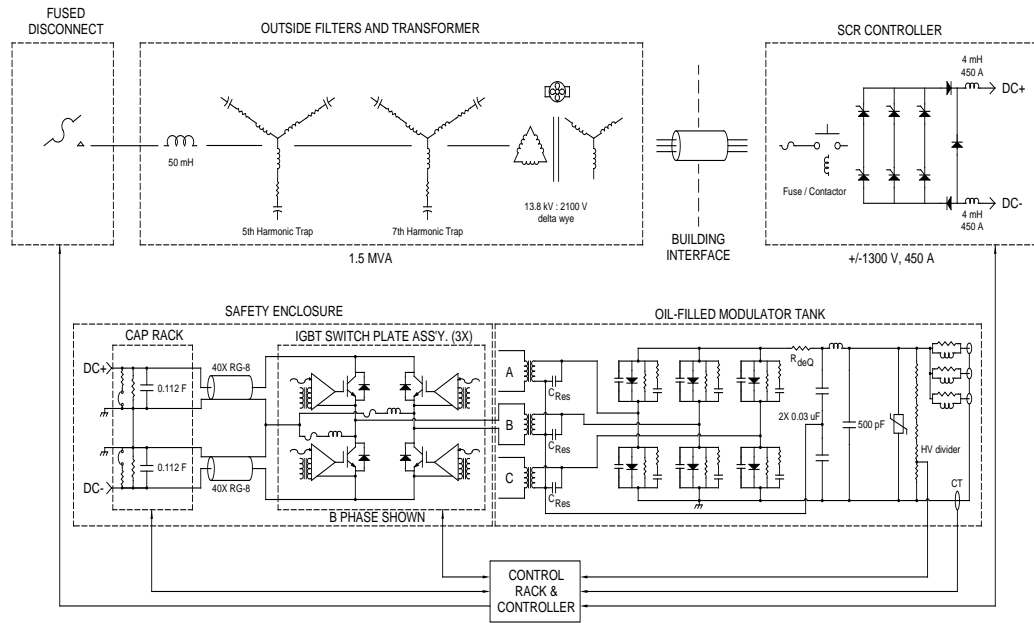
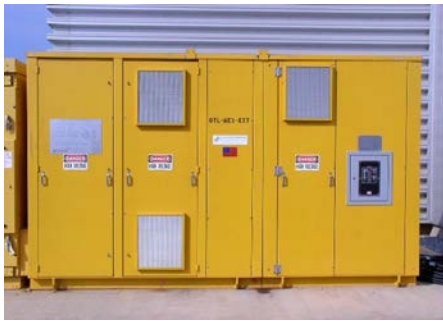
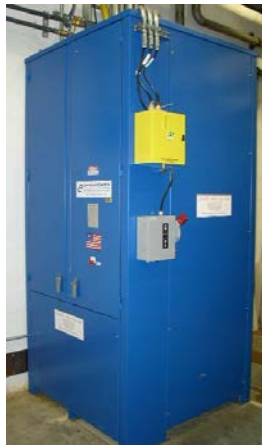
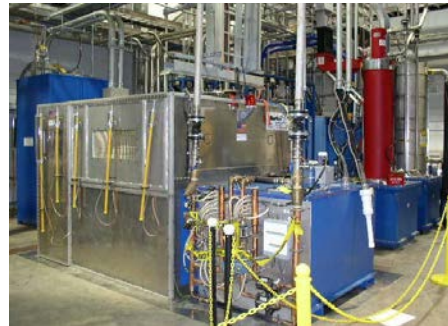
Modulators provide pulsed power to high power RF klystrons using 20 kHz switching with IGBTs

- Provides up to 135 kV, 1.35 ms pulses at 60 Hz to amplify RF up to 5 MW
- 3 phases employed to increase output ripple frequency
 - Minimizes output filter requirements
 - Minimizes fault energy available to klystron
- Powers multiple klystrons up to 11 MW peak power
- Currently there is up to a $\leq 5\%$ pulse droop operating in open-loop

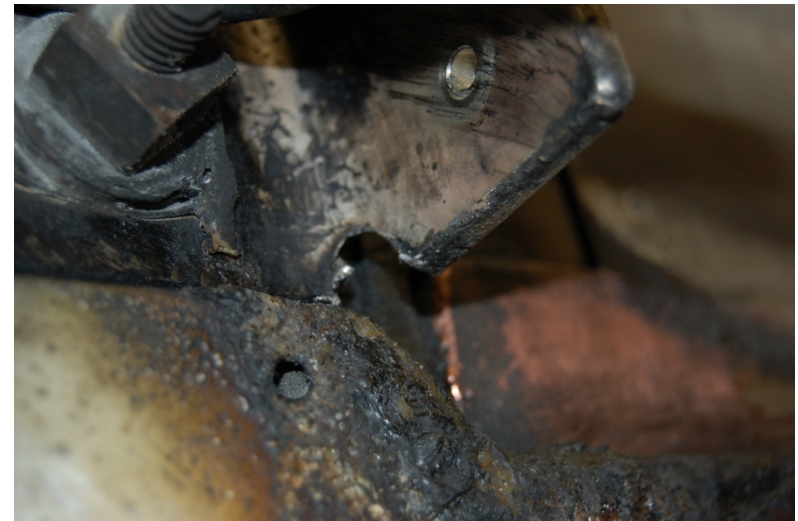
HVCM Fire Causes – Bus Arcing was an early failure mechanism

- Workmanship or residual dirt believed responsible
- Repeated arcing acted as ignition source for combustibles
- Corrected with improved training of assemblers and full peak power testing, no faults w/ same root cause since (Jan 07)

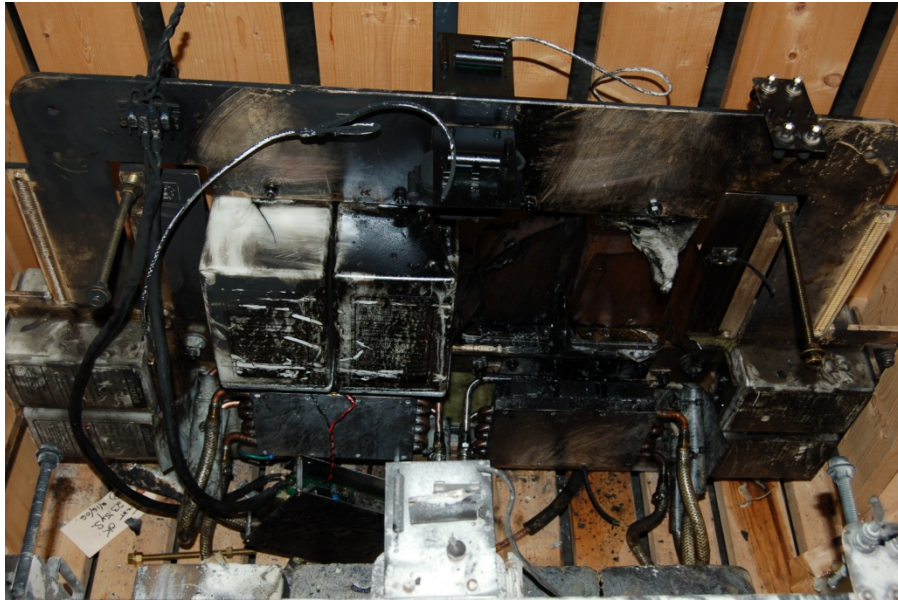
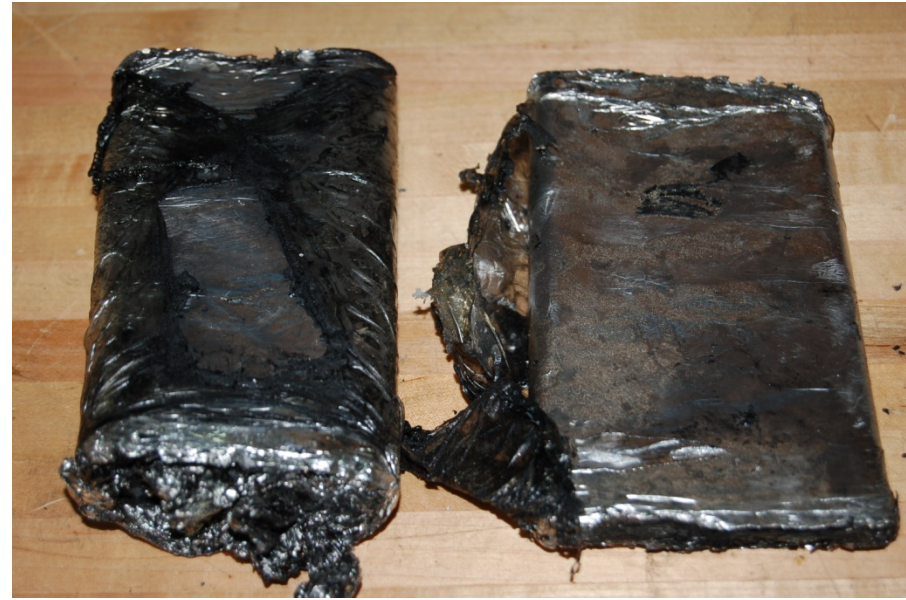
HVCM Fire Causes – Capacitors failures were quite catastrophic and identified low MTBF component

- Mfgr.'s cap lifetime ratings 100,000 hours @ 3000 V
- Experience indicates MTBF 10-15 khours @ ≤ 2300 V
- Alcohol-based dielectric fluid compounded the problem
- Replaced all caps w/ higher lifetime / metallized film caps (mfgr's MTBF = 150,000 hours)

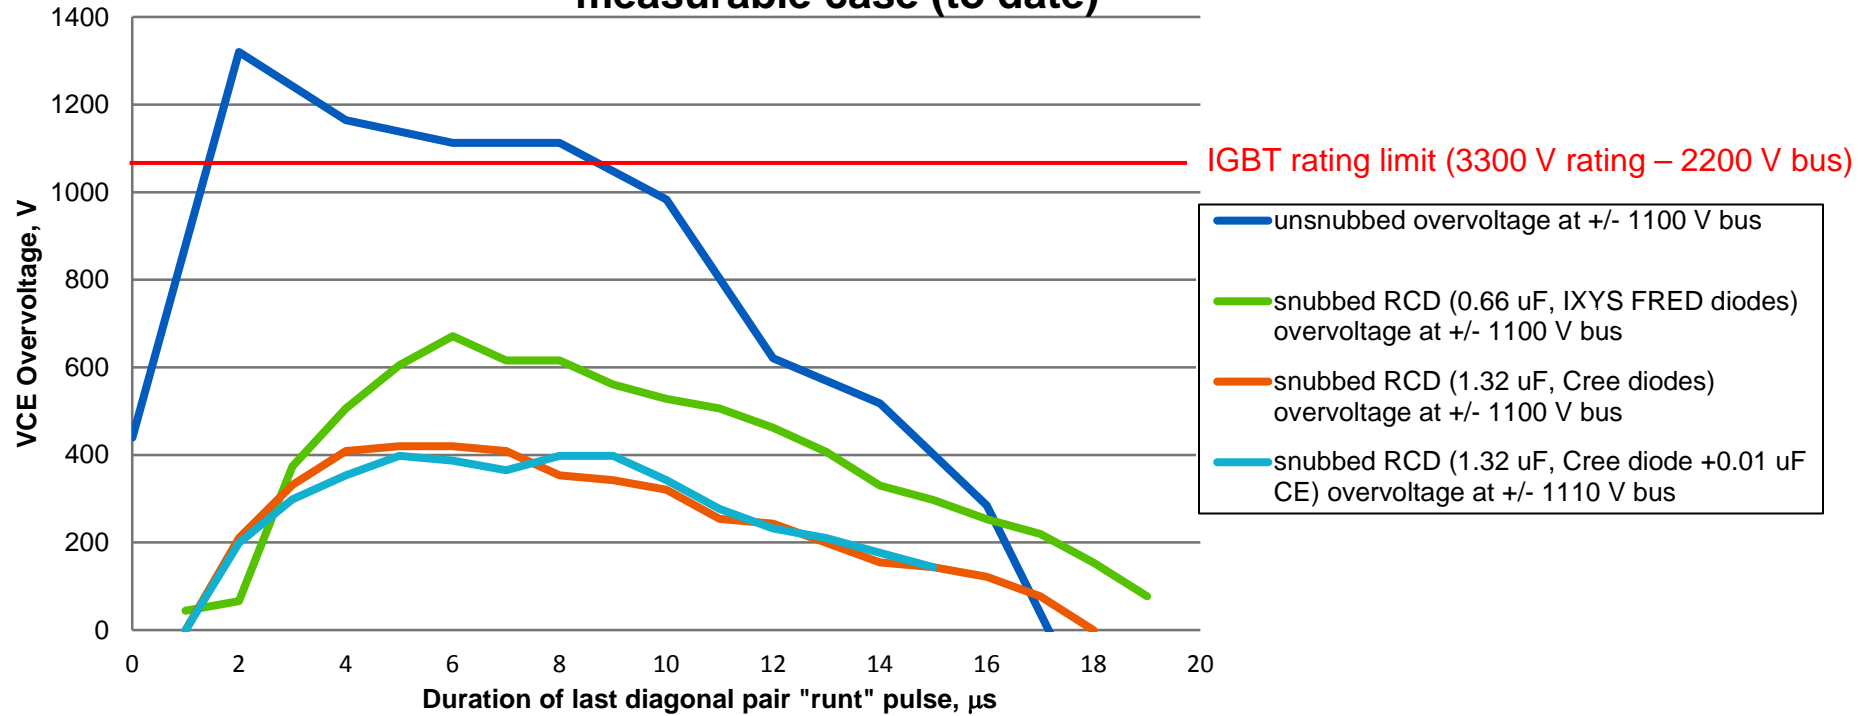
Adding IGBT snubbers permits higher voltage operation, reliable higher current IGBT operation & eliminates fault over-voltage problem

End Of Pulse IGBT Over Voltage at +/- 1100 V bus Operation, worst measurable case (to date)

- Installed on 5 of 15 operational modulators, 2 test stands
- Combined >5000 operational hours w/ no issues
- Necessary for reliable pulse flattening and improved IGBT reliability

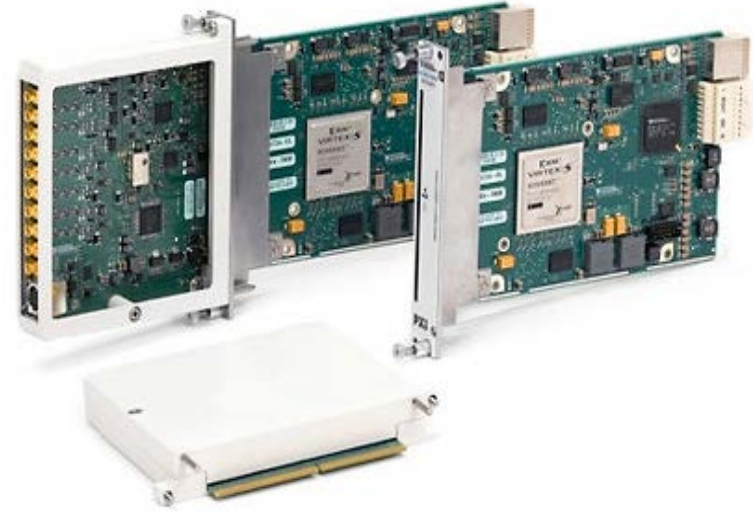
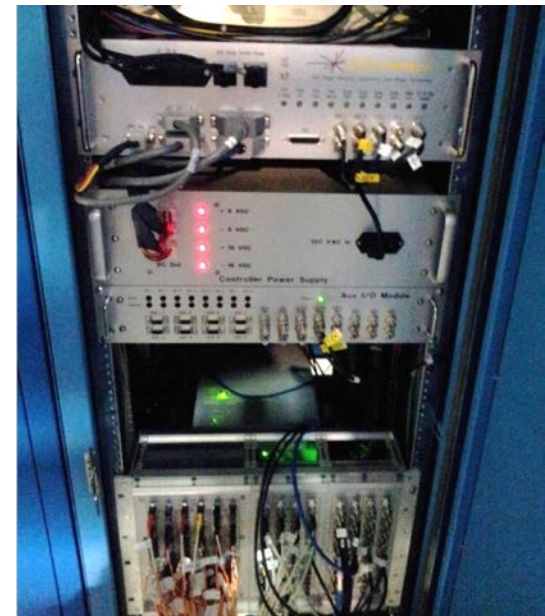
All these features available in a COTS package utilizing LabView for programming flexibility and ORNL ownership

- FlexRIO systems consists of:
 - An embedded controller for communication and processing
 - **Reconfigurable** chassis housing the user-programmable FPGA
 - Hot-swappable I/O modules
 - Graphical LabVIEW software for rapid real-time, Windows, and FPGA programming
- Custom interface modules are simple designs employing buffers and op-amps for signal conditioning and gain control
- Entire system should prove to be much more reliable, more easily maintained and permit more system flexibility

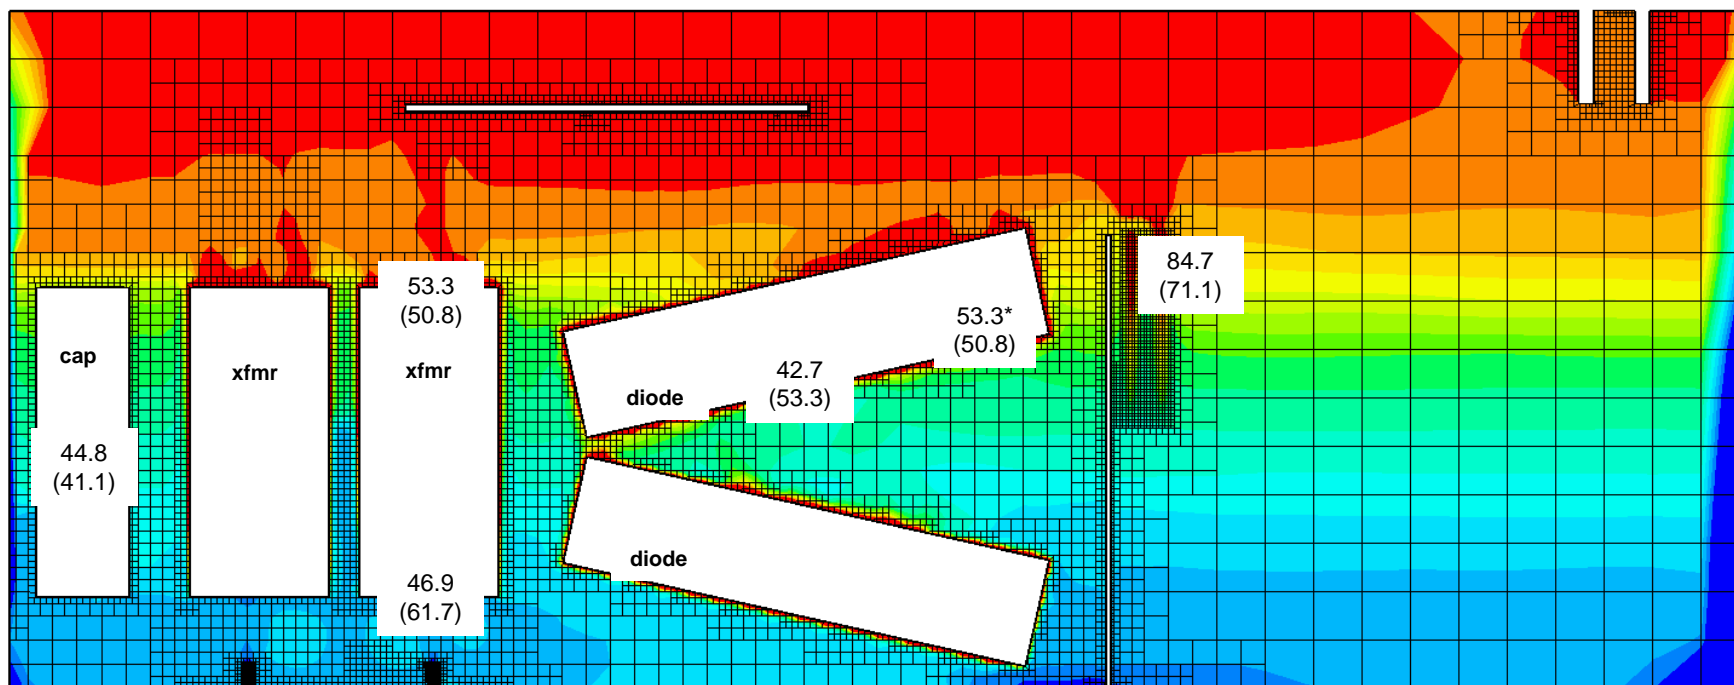
Simulations of temperature profiles and flow rates with current system reveal system shortcomings

- Actual measured temperatures at rated power shown in °C in white boxes
 - Temperature after testing with prototype shown in parenthesis
- Even lower temperatures can be achieved with improved oil circulation
- Should permit a factor of 2 or better increase in component MTBF
