Vacuum System Reliability Illustrated with LHC

V. Baglin

CERN TE-VSC, Geneva

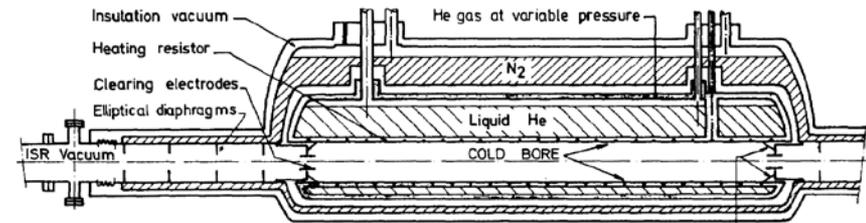
Fig. 2. Cold-Bore Cryostat - Schematic Outline.

IEEE Transactions on Nuclear Science, Vol. NS-24, No. 5, June 1977
A VACUUM COLD BORE TEST SECTION AT THE CERN ISR
C. Benvenuti, R. Calder, M. Milleret
CERN
Geneva, Switzerland

Summary
A 2 m helium cooled vacuum test section has been inserted into the CERN ISR to investigate problems molecules are adsorbed as ions than secondary molecules are released (beam pumping).
In the CERN ISR, in which, for geometrical reasons,

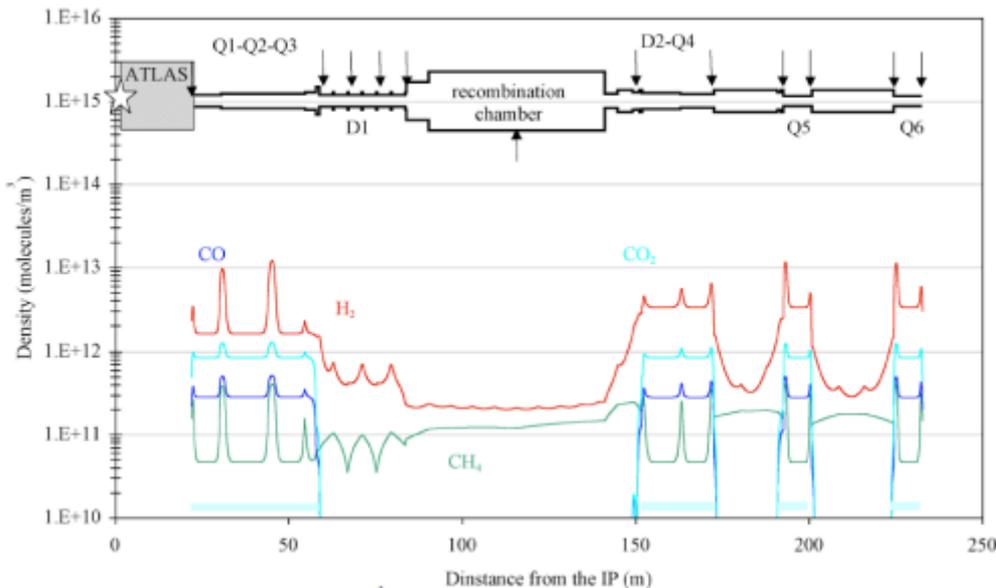
- **Life time limit** due to nuclear scattering ~ 100 h
 - $n \sim 10^{15} \text{ H}_2/\text{m}^3$
 - $\langle P_{\text{arc}} \rangle < 10^{-8} \text{ mbar H}_2 \text{ equivalent}$
 - ~ 80 mW/m heat load in the cold mass due to proton scattering

- **Minimise background** to the LHC experiments

H2_eq / m3	mbar
$\langle \text{LSS}_{1 \text{ or } 5} \rangle$	$\sim 5 \cdot 10^{12}$	10^{-10}
$\langle \text{ATLAS} \rangle$	$\sim 10^{11}$	10^{-11}
$\langle \text{CMS} \rangle$	$\sim 5 \cdot 10^{12}$	10^{-10}

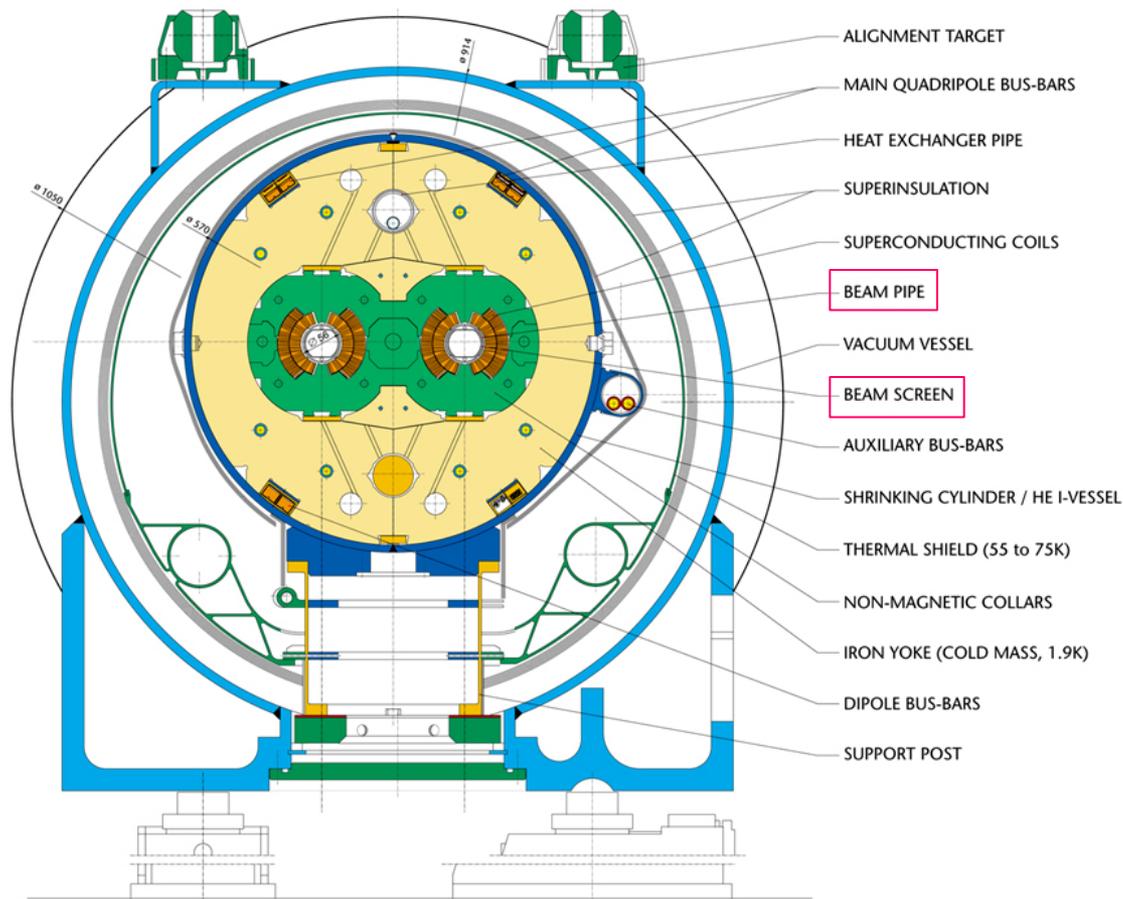
LHC DIPOLE : STANDARD CROSS-SECTION

LHC Dipole Vacuum System

- Cold bore (CB) at 1.9 K which ensures leak tightness
- Beam screen (BS) at 5-20 K which intercepts thermal loads

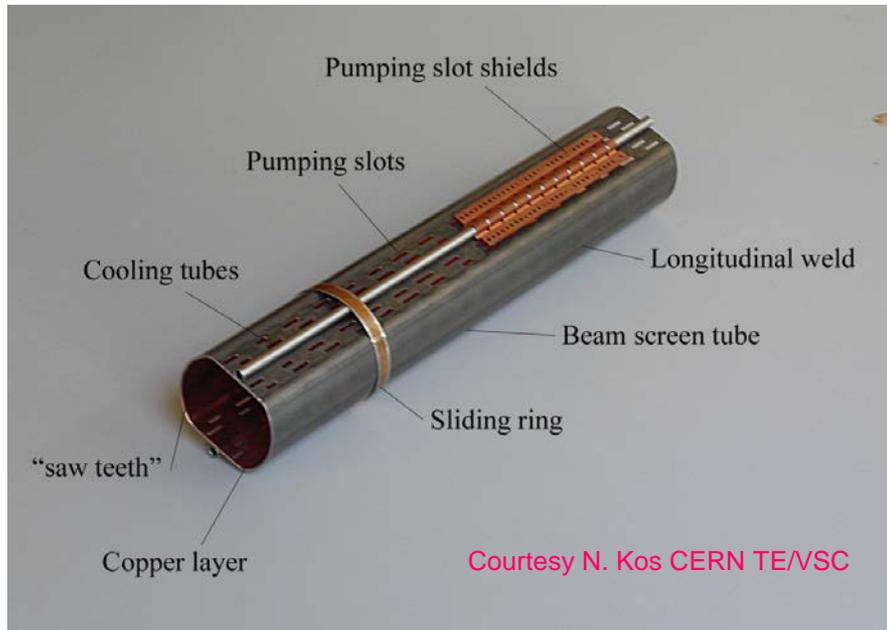
New System: LHC Beam Screens

- An **innovative and complex** system, produced at several 10 km scale !
- **Intercept the heat load** induced by the circulating beam
- Operate between 5 and 20 K
- Pumping holes to **control the gas density**

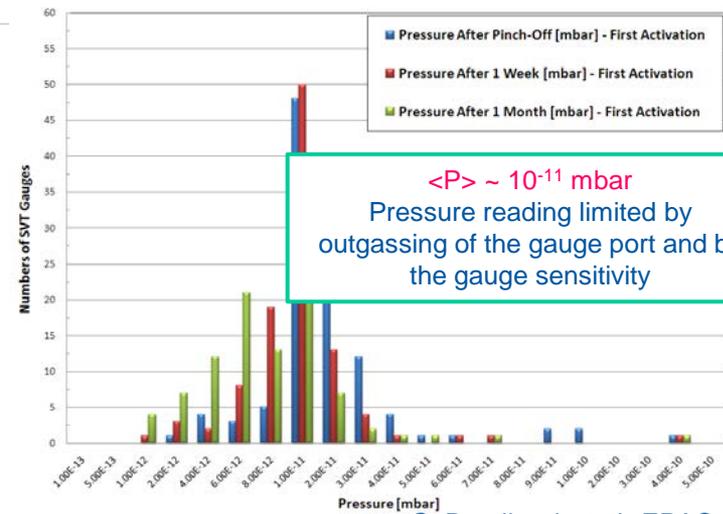
$\langle P \rangle \sim 10^{-11}$ mbar
Pressure reading limited by outgassing of the gauge port and by the gauge sensitivity

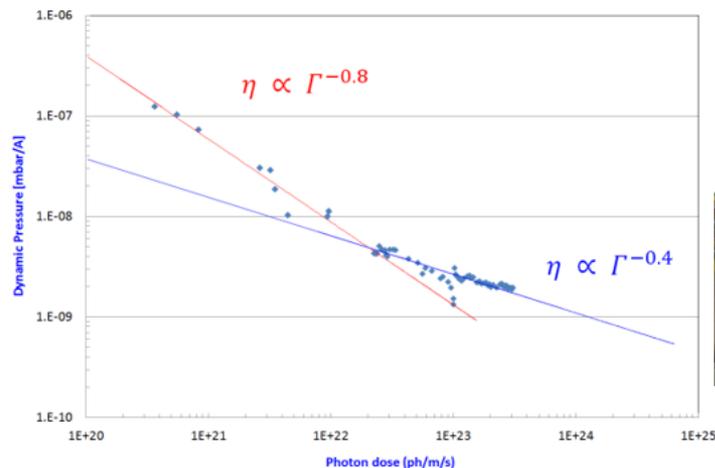
- Arc extremity's vacuum gauges : unbaked Cu and cryogenic beam screen
- Reduction by **2 orders of magnitude** since October 2010

- 2 trends :
 - Room temperature
 - Cryogenic temperature

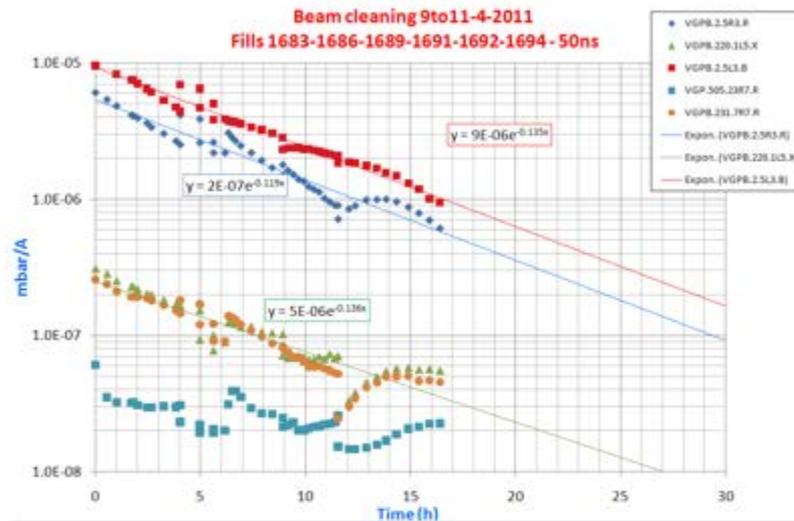
2011 Scrubbing Run with 50 ns Bunch Spacing

- As expected, strong pressure reduction with time were observed

- Which allowed to fill-in the machine with nominal parameters the 7-12-2012 with 25 ns bunch spacing

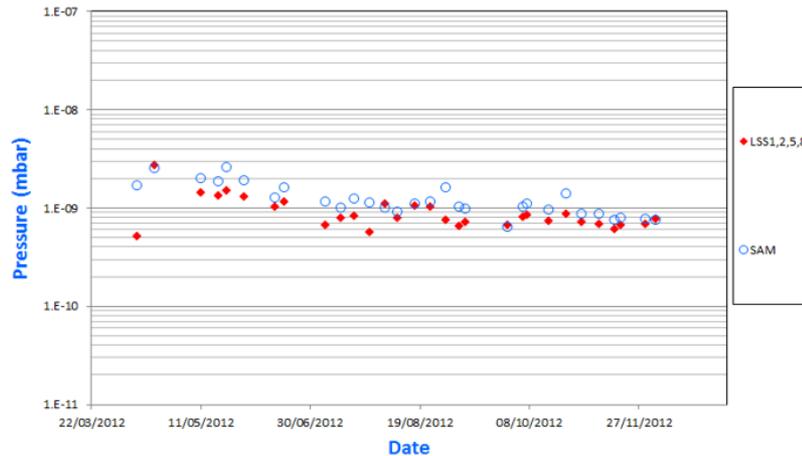
2012: LHC LSS Average Pressure with Beam

- Reduction throughout the year while increasing beam intensities from 200 to 400 mA
- $\langle P_{LSS} \rangle \sim 7 \cdot 10^{-10}$ mbar

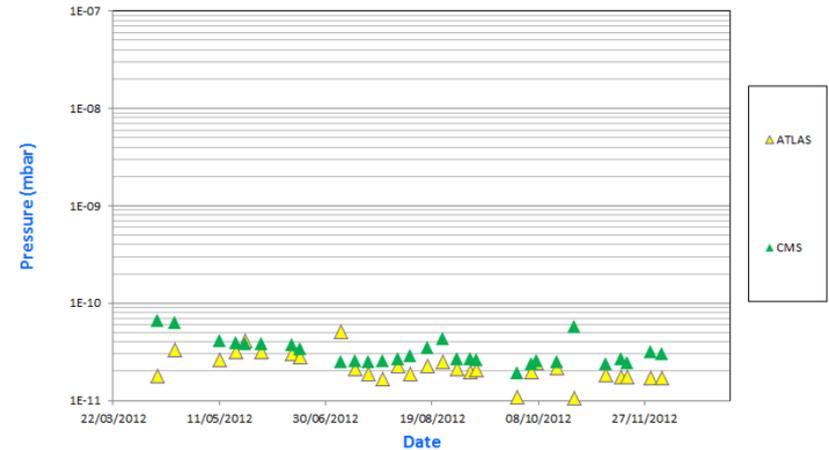
2012: LHC Experiments Average Pressure with Beam (IP only)

- Almost constant pressure during the year
- $\langle P_{LHC\ Experiments} \rangle \sim 3 \cdot 10^{-11}$ mbar

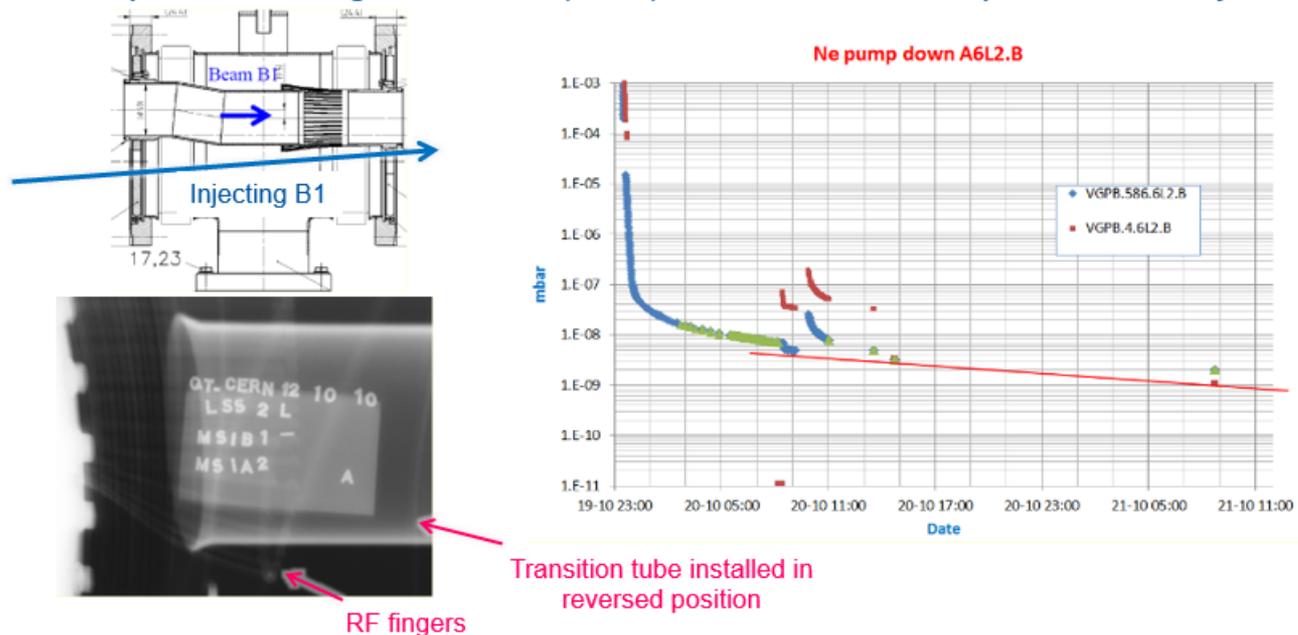
October 2010: Injection Septa in A6L2.B

- Reverse mounting of a vacuum module during installation
 - Unfortunately, that was the injection area so RF fingers started to be damaged by the incoming beam. A bump was needed to inject properly into LHC !
- Ultra-pure Ne venting 19-10-2010 (wk42), allowed to resume operation in 3 days

Fast recovery following RF bridge repair: operation resumed in 3 days

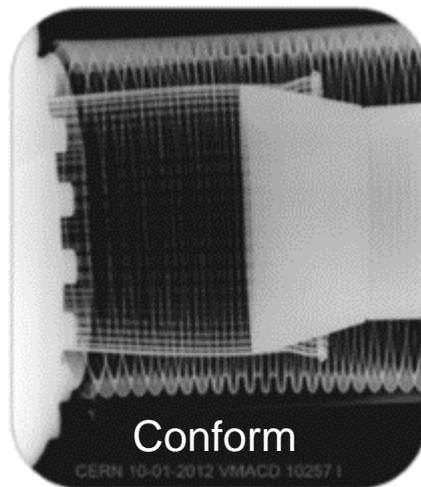
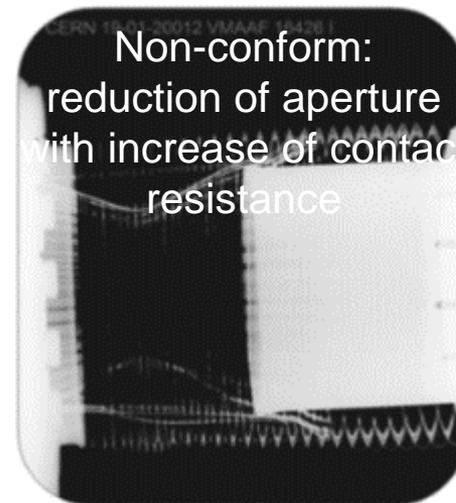
- As a consequence of the previous repair, a **systematic X-ray** analysis of all the vacuum modules was done: 1800 X-rays were taken during 2 years.
- The **repair** of 96 non-conform vacuum modules (~ 5% of the total) was needed to **restore machine impedance** and to **avoid pressure spikes/excursion** (*i.e.* avoid beam dumps).
- 52 RT vacuum sectors impacted out of which 29 are opened during LS1 **on purpose** (~ 200 kCHF manpower)

- ➔ Identify and classify the non-conformities
- ➔ Repair them !

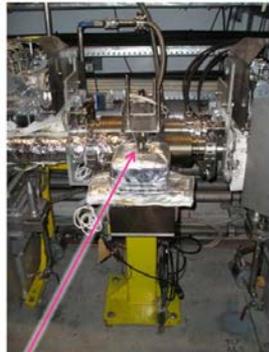
- Consolidation of pumping scheme, main activities :
 - reduce **background** to the experiments:
 - NEG coating of RF bridges inserts located inside and in the vicinity of the LHC experiments
 - 180 inserts to replace
 - **minimise impact of radiation** onto the personnel:
 - installation of remotely powered NEG cartridge as complementary lumped pumping system in collimators areas
 - 190 D400 NEG cartridges to install

Figure 2: Schematic of the collimator area with installed NEG cartridges (180 Torr and 400 Torr).

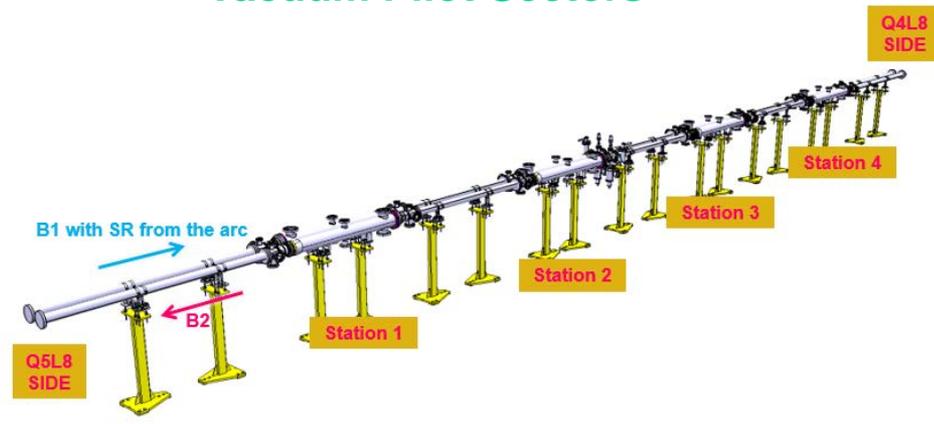
Figure 1: Pilot sector schematic

Vacuum Pilot Sectors

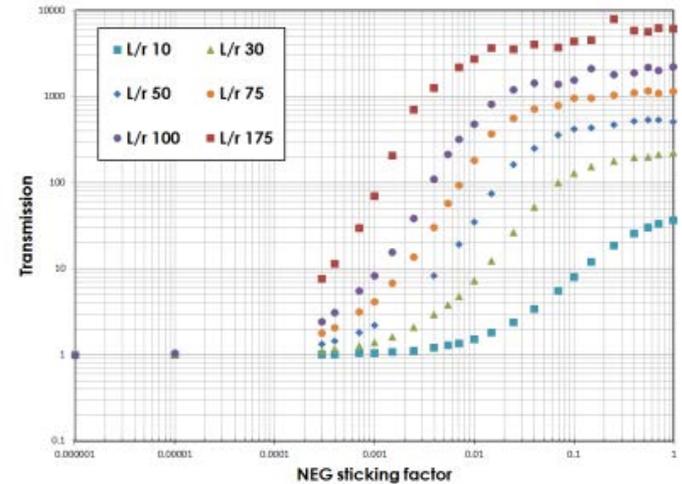
Pressure ratio yields the NEG sticking factor

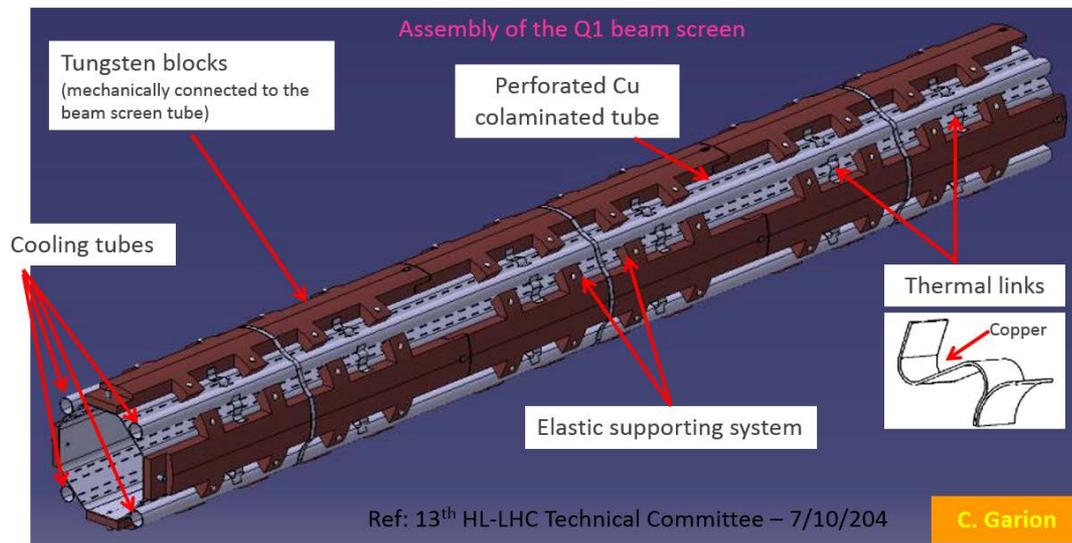
Impact of debris onto IT+D1: shielded beam screen

- Operating temperature : 40 -60 K
- 16 mm absorbers in Q1, 6 mm absorbers from Q2 to D1

- Design studies underway
- Mechanical analysis : impact of quench, heat transfer, supporting system
- Tests with tungsten prototypes

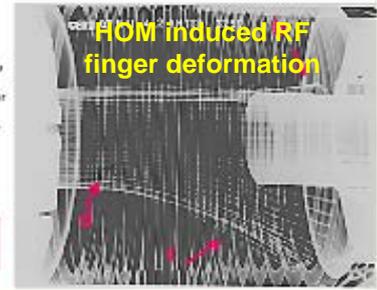
QQBI.26R7 line V2

Typical default, DCUM 3259.3524

Left side
Side view (only from corridor to TBL)
Metallic noise due to loose spring when filling vacuum chamber
RF fingers bending due to broken spring
Aperture reduced?
Non Conform
Spring was broken between May and November 2011.

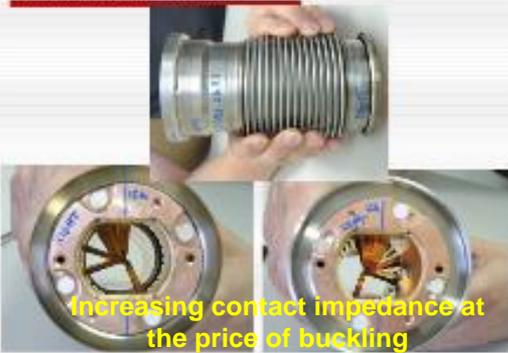
Increasing contact impedance at the price of buckling

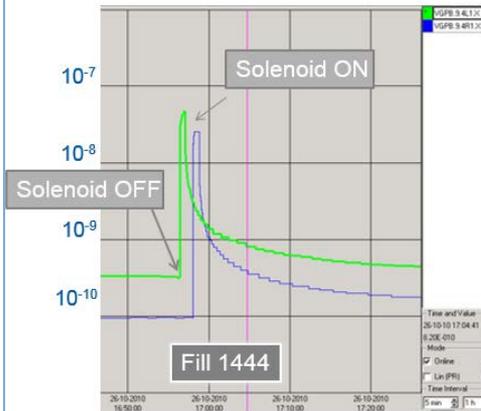
- The position at 45 m from the IP is the **longest unbaked area** (operating at RT) in LHC, so the first candidate to trigger electron cloud

Magnetic field of solenoid= 20 Gauss

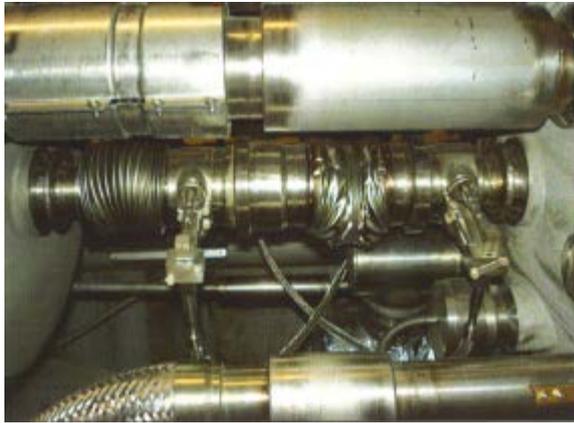
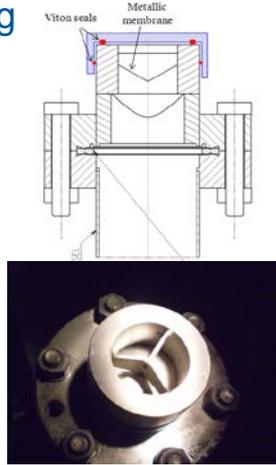
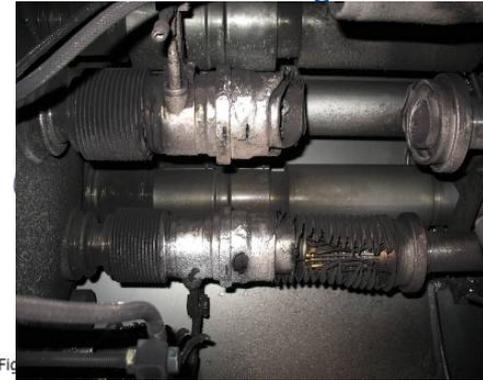
Fig. 15

- Following sector 3-4 incident in September 2009
- ~ 850 rupture disk installation at each arc's quadrupole (SSS) to mitigate bellows buckling in case of he inrush
- Protective half-shells in case of arcing

Protective half-shells for cryomagnet interconnections
