# Improvements on the ALBA synchrotron light source operation reliability

*Ferran Fernandez*

*ARW2015*

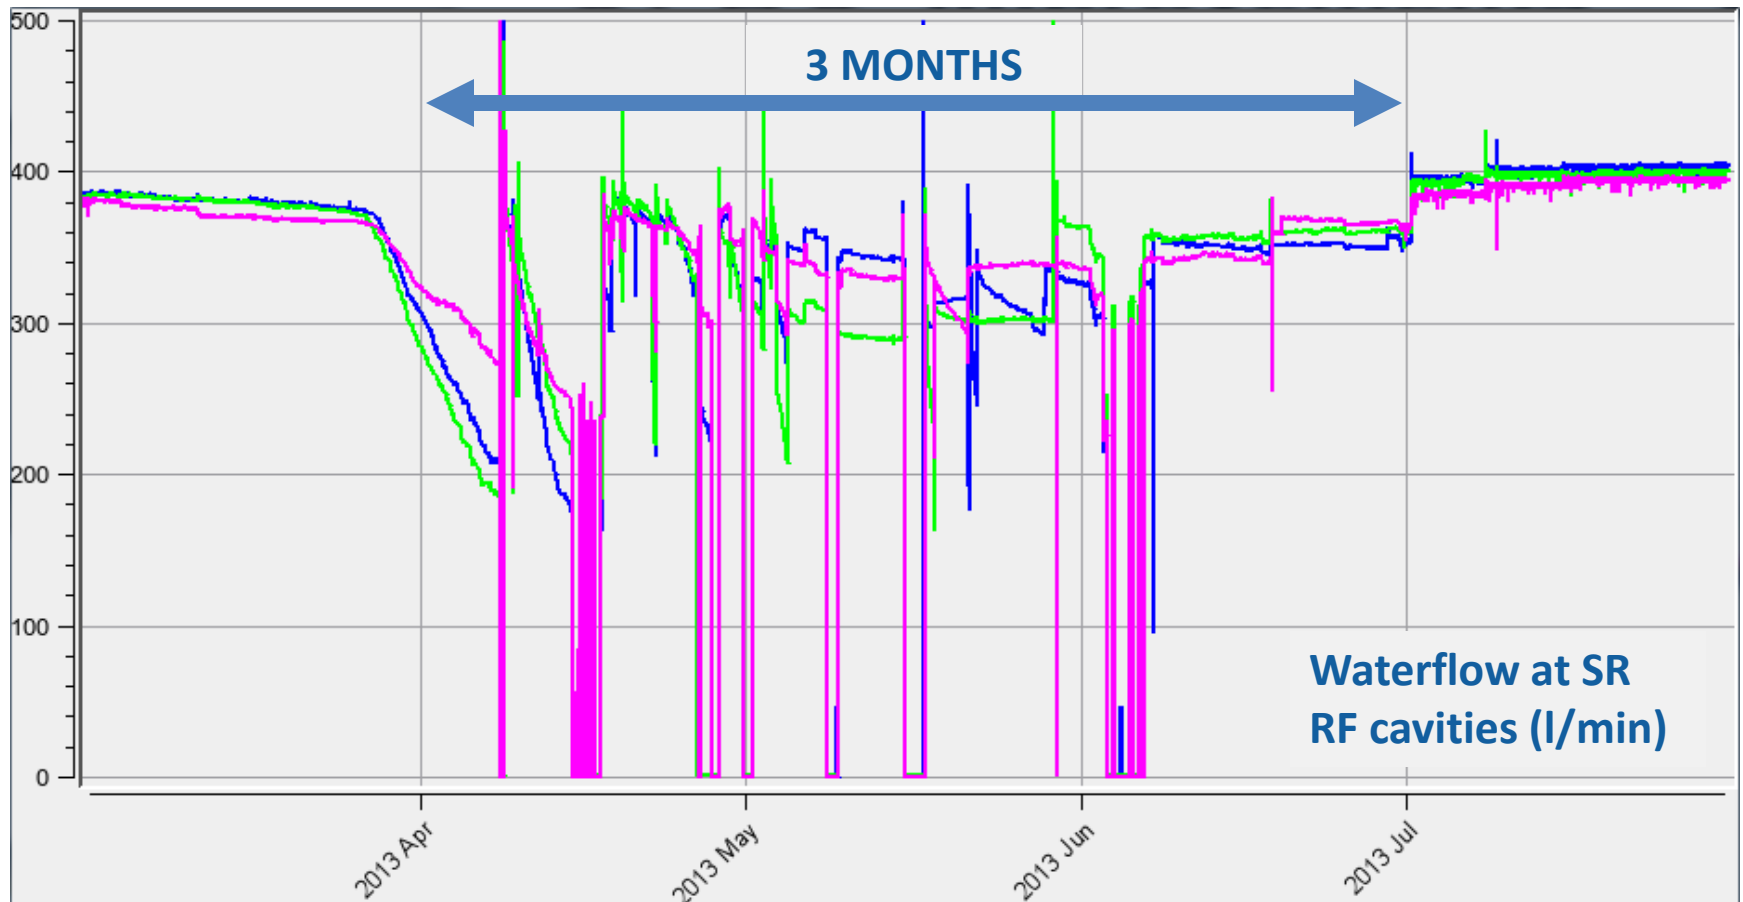
- *Apr – Jun 2013 water flow failure*

- ALBA facility water cooling system. Four different circuits with a common return: Storage Ring, Booster, Service Area and Experimental Hall.

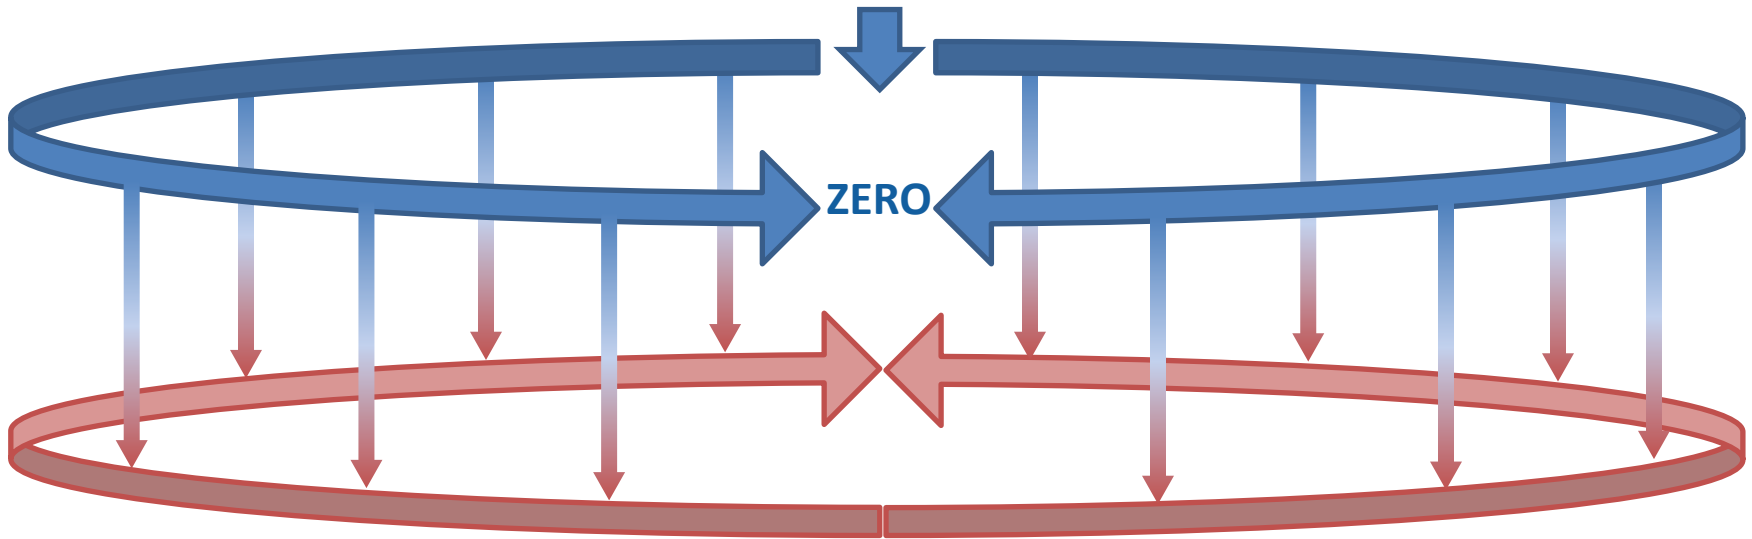
- *ALBA facility water cooling system weaknesses:*
  - *180° circulation with zero velocity point*

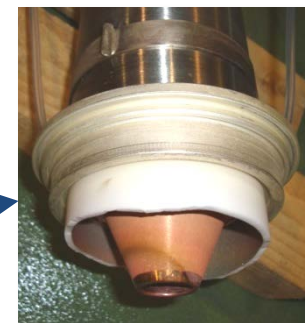
- *IOTs (6/16 broken during SAT)*

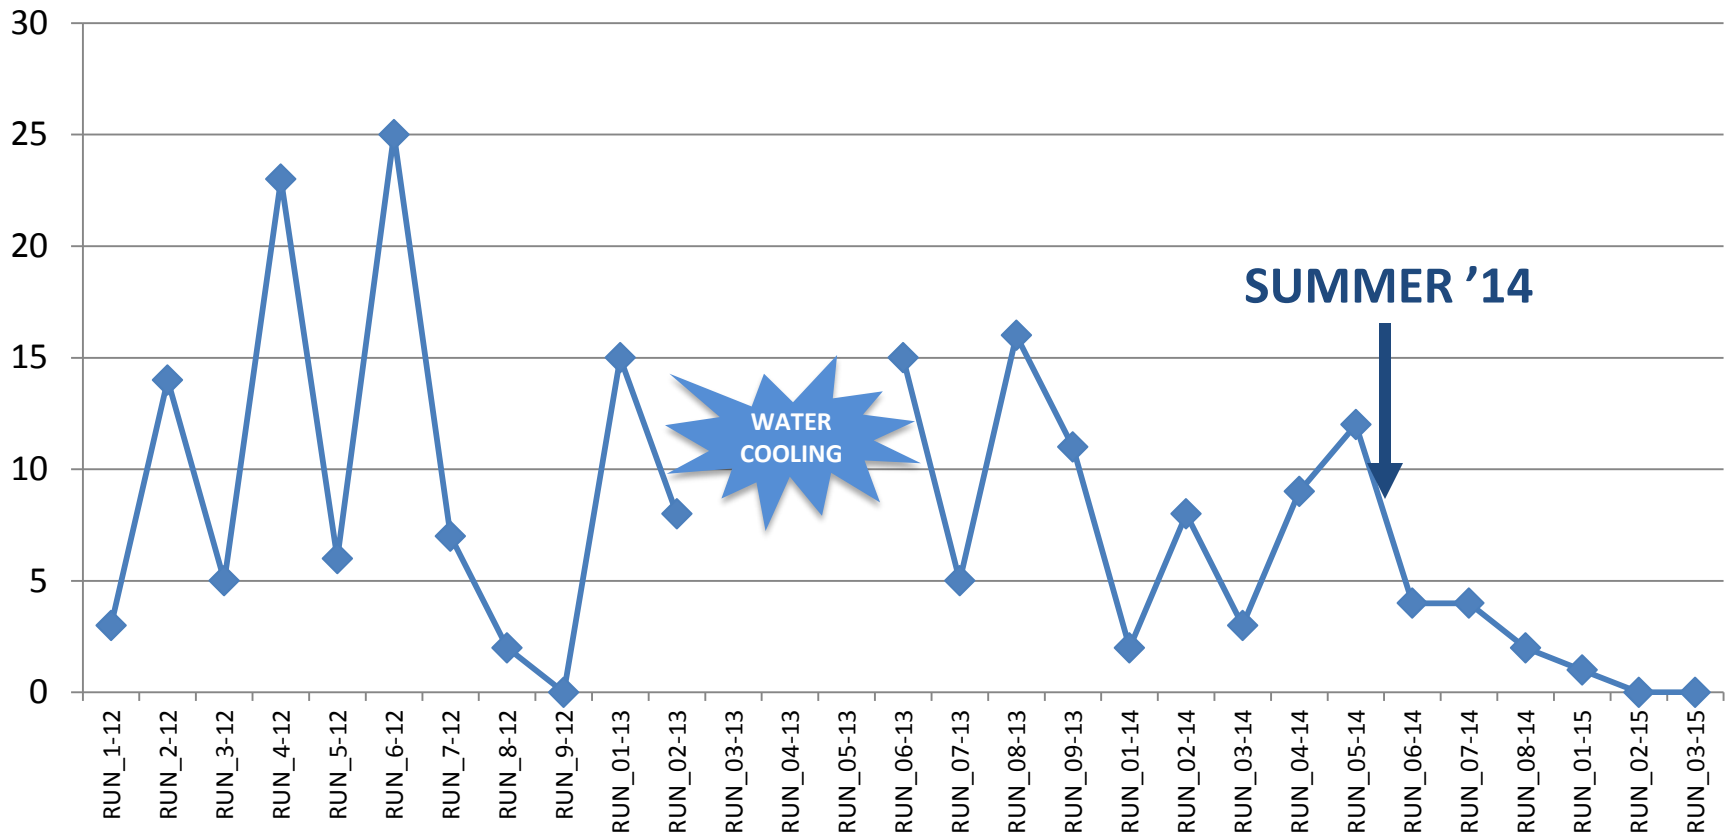
- *Evolution of beam dumps due to RF*

- *Fake interlocks*

- Water interlocks
- Signals crosstalk

- *Body current*

- Procedure conditioning next Monday (summer '14)
- Procedure recover from body currents(summer '14)

- *Voltage from 36kV to 32kV (summer '14)*

- *Old IOTs (>20000h) limited to 40kW (summer '14)*

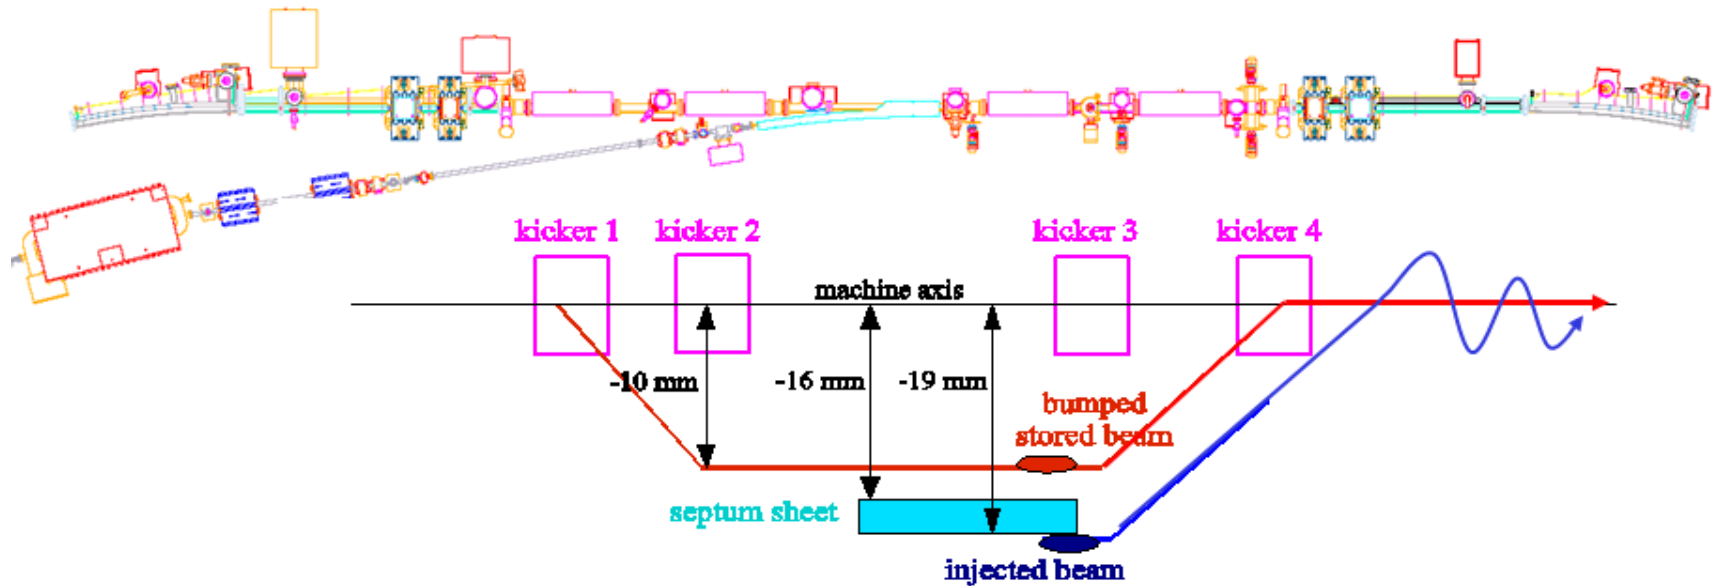
- The thyristor driver board of kicker 02 of the storage ring had an erratic behavior: 1 trip/malfunctioning per month

- Damaged components: MOSFET IXDN614 and IXDI614, which are the gate drivers used to switch the thyristors
- A TLD radiation study showed high dose levels focused at kicker 2.

- Polyethylene and lead shielding was installed. After shielding, failures disappeared
