ISIS Main Ring Dipole Coil Failures

30th April 2015

Accelerator Reliability Workshop
Knoxville

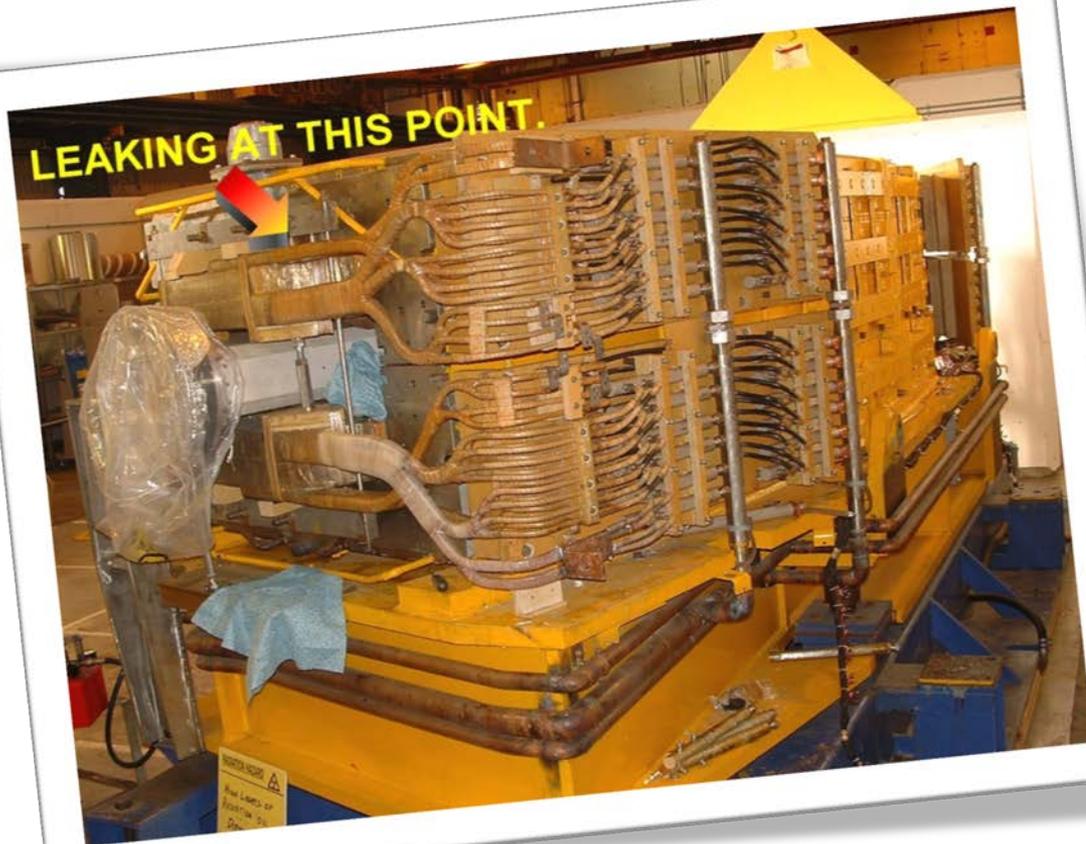
- Original coils made by Tesla Engineering in early 1980's
- Constructed using a Mica / Glass tape then vacuum impregnated
- Original coils in service since then (some are still going...)
- Started to see failures in 2002

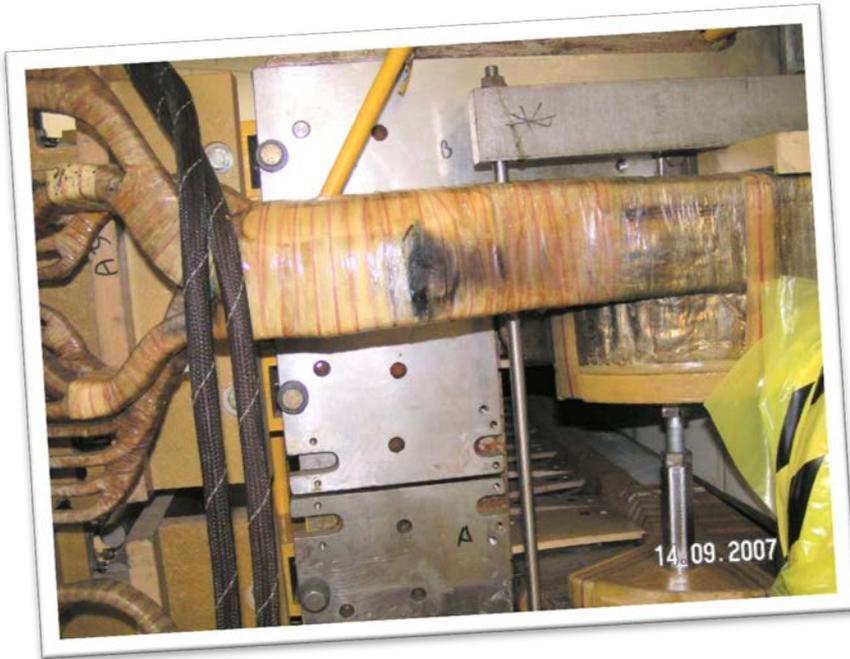
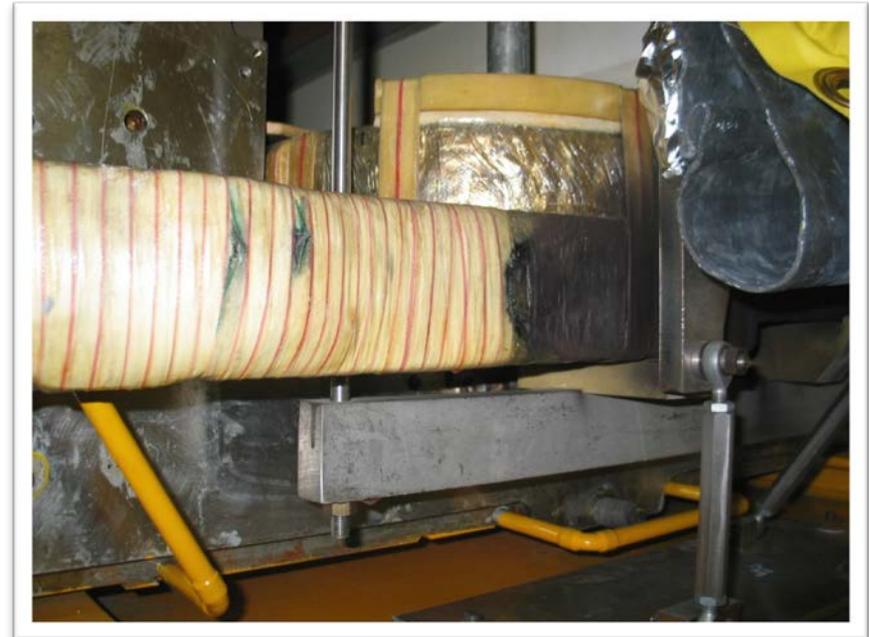
- Further failures in Dec 2006 and Sept 2007
- More coils procured with a new manufacturer
- Some new coils now being installed in machine

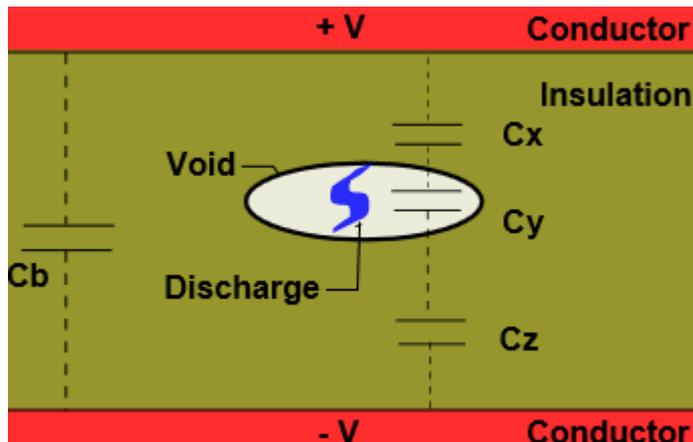
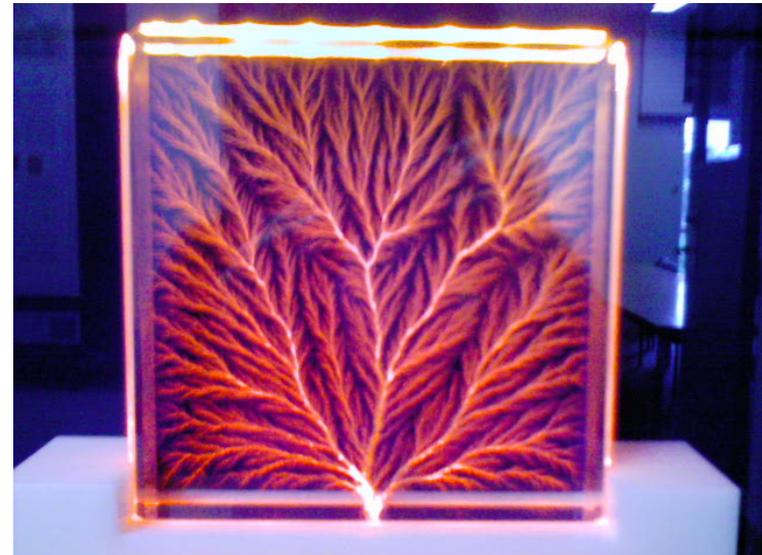
- In 2004 were made without Mica in the insulation system
- There is a good chance that the failure mode (in new coils) is via partial discharge...
