# MEBT Water to Vacuum Leak

Geoffrey Milanovich  
SNS Operations

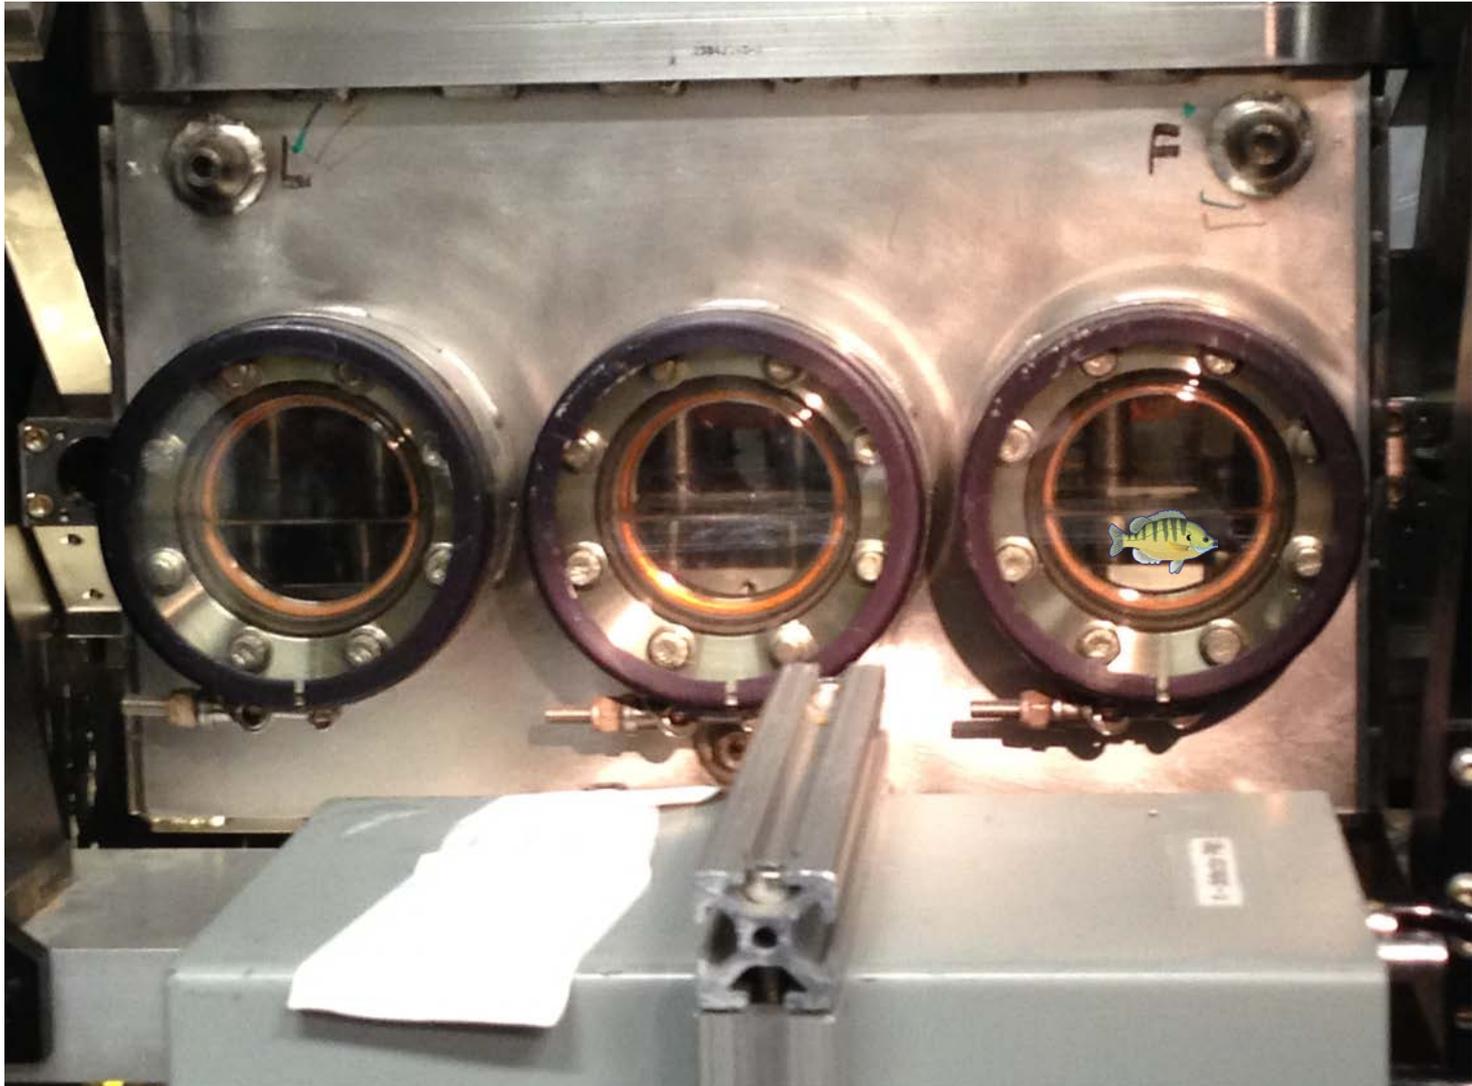
- 12:28 – Vacuum alarms from front end
- 12:29 – Water system alarms from front end
- Investigating vacuum remained top priority for ops.
- Water techs were called about water system.
- When report of water leaking onto floor near beampipe came in, operators shut off water system (15 minutes)
- Water to vacuum leak is (thankfully) an extremely rare occurrence!

Uh-oh!

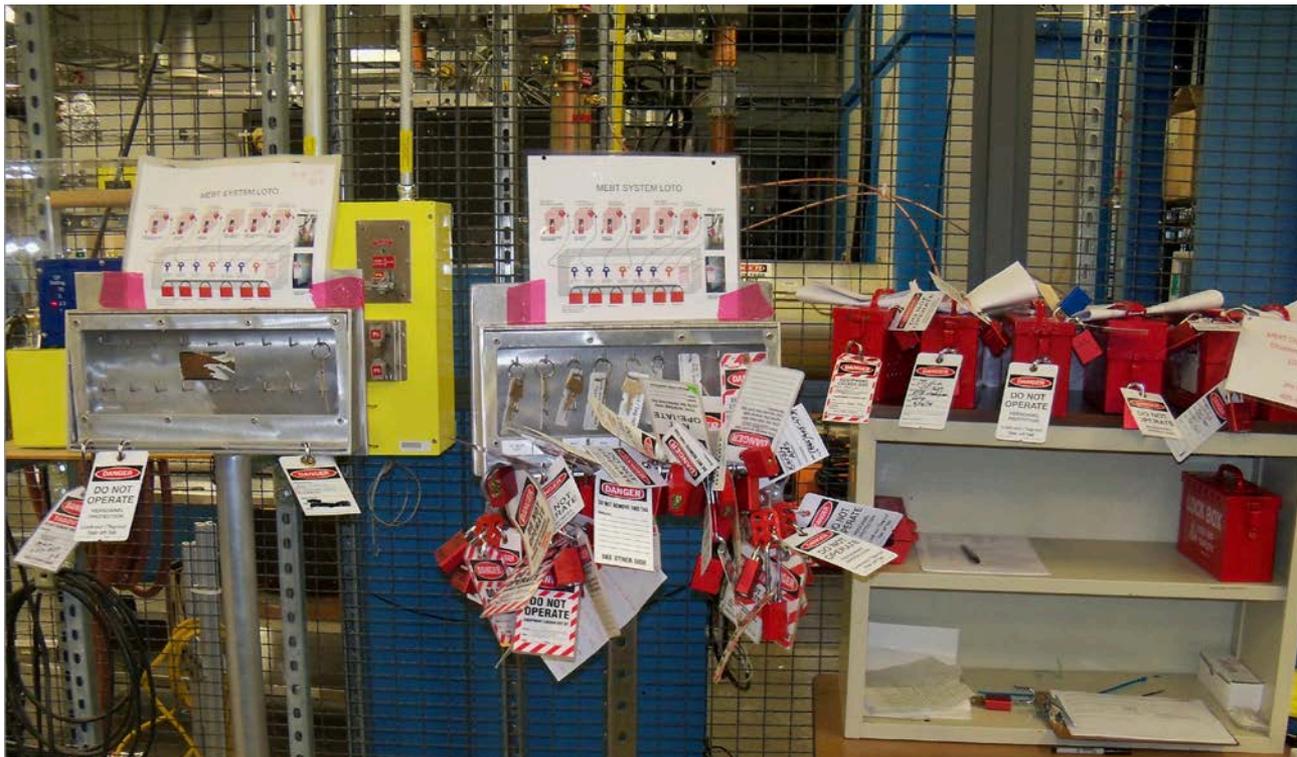
- LOTO: Examined all unusual sources of energy that could arise from water in the beam pipe. Changed LOTO as required to support work.

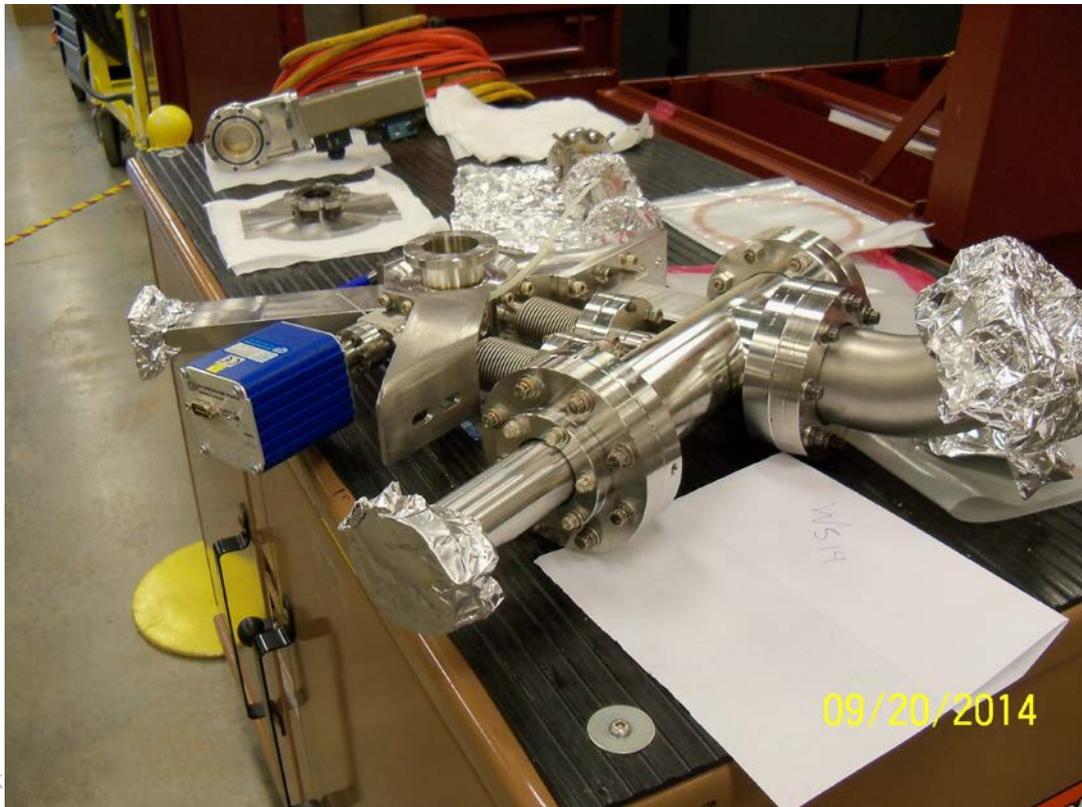
- Radiation: Initial survey of water found no issues. Buffer area established near work zone to store parts. Surveyed parts if removed from buffer area.
